GENERAL COMMITTEE

Tuesday, January 26, 2021
Meeting Number 2021 – 01

SUBJECT: OUTDOOR POOL CONDITION ASSESSMENT

Pool Condition Assessment

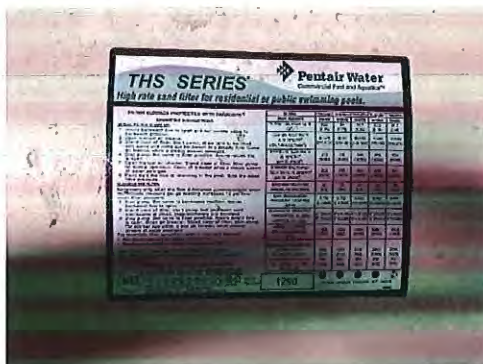
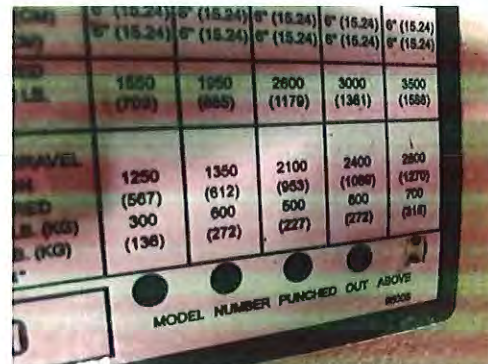
A minimum flow rate of 860 GPM would be required to meet current code and standards for a Class A Public Pool. If this were the case, the filtration system would need to be upgraded to have a minimum recommendation filter area of 65 sq ft, which would achieve a filtration rate of 12.85 GPM / Sq. Ft.

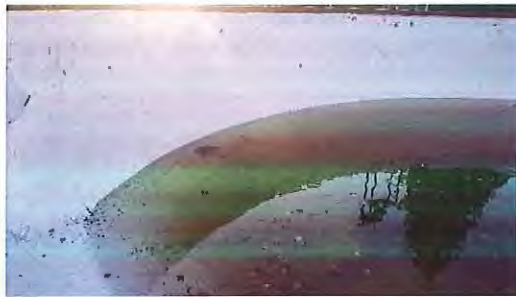
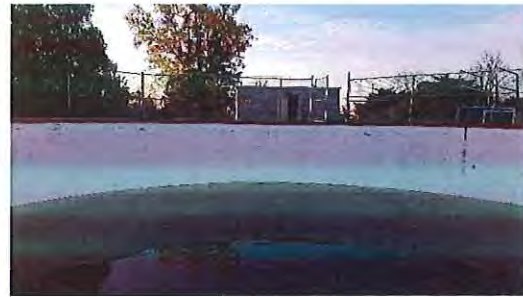
There are two pool main drains noted by staff in the deep end of the pool. We were visually unable to inspect these drains, as they were underwater and covered in leaves. Current industry safety standards regarding main drain anti-entrapment require pools to have anti-entrapment "unblockable" drain covers installed. An "Unblockable drain" includes a suction outlet defined as all components, including the sump and/or body, cover/grate, and hardware such that its perforated (open) area cannot be shadowed by the area of the 18"x23" Body Blocking Element of ASME/ANSI A112.19.8-2007. Domed drains of the same current size would typically meet this requirement, however, the current drain covers were thought to be flat and under the noted 18"x23" size, which in turn could pose a possible entrapment hazard (even though these drains are connected to the surge tank via gravity, these are still a suction entrapment hazard due to the high head pressure from the deep water on top)

Condition:	Unable to Verify
Priority:	High (if not "Unblockable")
Current Code Compliant:	Unable to Verify

A minimum flow rate of 860 GPM would be required to meet current code and standards for a Class A Public Pool. If this were the case, the main drain sumps and covers would need to be upgraded to meet the increased suction flow and velocity that would be passing through them. A maximum velocity of 1.5 ft/second is required at both main drains, assuming full flow through each.

- 2) The existing mains drain covers are to be inspected, and if they are below the size of 23" x 18" (each) and not domed, these drain covers are to be replaced with Unblockable domed drain covers. This will ensure all current code, safety, and industry standards are being met regarding main drain anti-entrapment conditions.

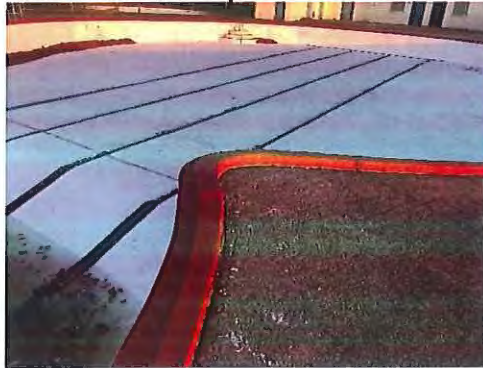
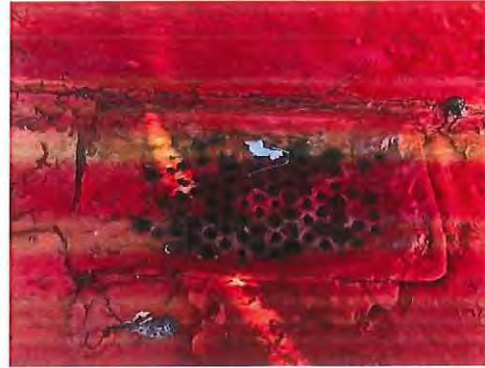
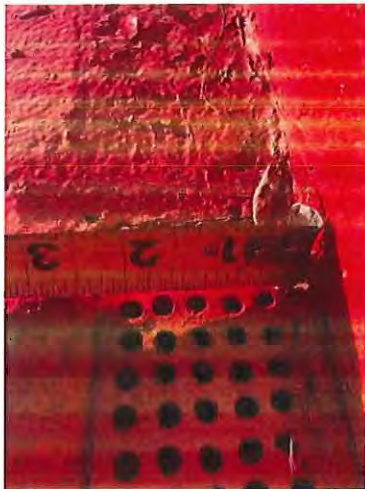
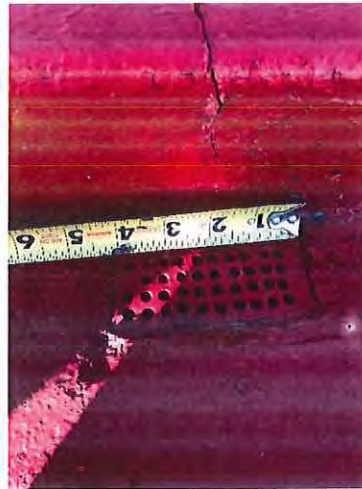
d) SKIMMER/GUTTER DROP-OUTS

This pool tank is built with an older-style gutter drop out system around the perimeter to accommodate surface skimming/cleaning of the pool water. The system is designed to have the water overflow along the entire perimeter onto a ledge, where there are various small drop-out ports (18 at this location) that the water will flow through, where it should taken into the underground surge tank. From there, it would be filters and treated through the recirculation system and sent back to the pool. The current system does not operate this way, and any water entering the drop-outs is sent directly to waste.

This system is currently providing very little in the way of surface skimming. The ports are very small and spaced out around the perimeter. 90%-95% of the water that flows up onto the overflow ledge flows back into the pool, with a very little amount actually flowing down through the gutter drop-outs. Also, the pool has shifted slightly over time, making the overflow perimeter uneven. This results in water no overflowing onto the ledge at all locations around the perimeter. This overall design and condition does not provide proper surface cleaning and recirculation of the water within the pool tank, and results in a much lower water quality than is desired and recommended by current code and health standards.

Condition: Poor
Priority: High
Current Code Compliant: No

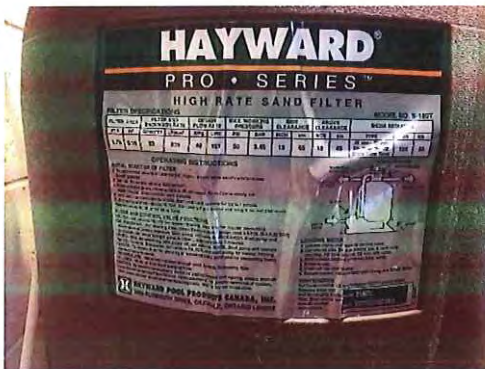
A minimum flow rate of 47 GPM would be required to meet current code and standards for a Wading Pool. If this were the case, the filtration system would need to be upgraded to have a minimum recommendation filter area of 2.75 sq ft, which would achieve a filtration rate of 12.73 GPM / Sq. Ft.

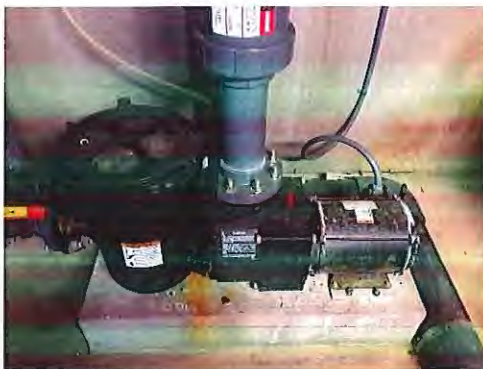
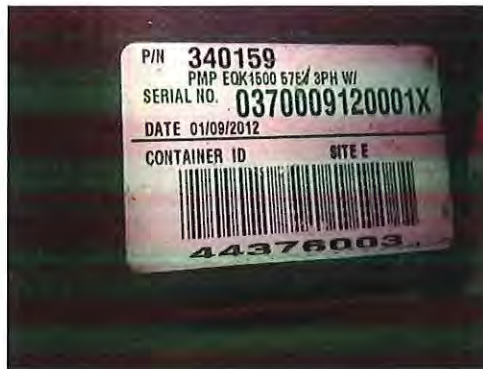
The pool recirculation pump is a 15HP, 3 Phase, 575 V pump, and was noted to be in good condition. Although there was some minor corrosion noted on the motor of the pump, the pump was otherwise noted to be in generally good operating condition.

Condition: Good
Priority: Low
Current Code Compliant: No

A minimum flow rate of 860 GPM would be required to meet current code and standards for a Class A Public Pool. This flow rate would require a larger pump, which in most cases would be a 20 HP pump, rated at 70' TDH.

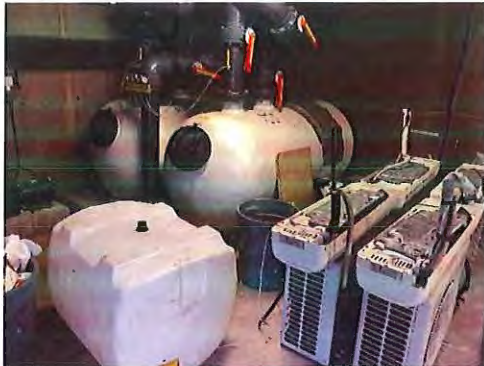
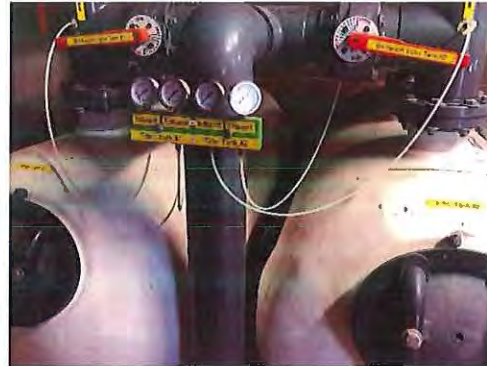
A minimum flow rate of 860 GPM would be required to meet current code and standards for a Class A Public Pool. If this were the case, the filters would need to be upgraded to have a minimum recommendation filter area of 65 sq ft (total), which would achieve a filtration rate of 12.85 GPM / Sq. Ft.

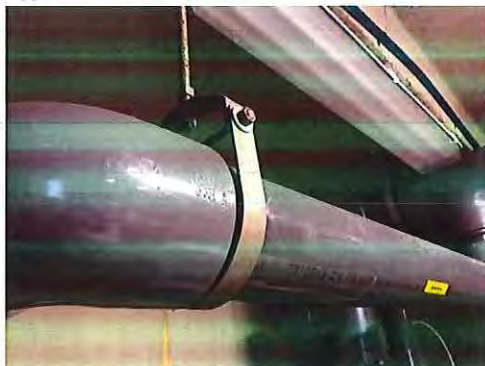
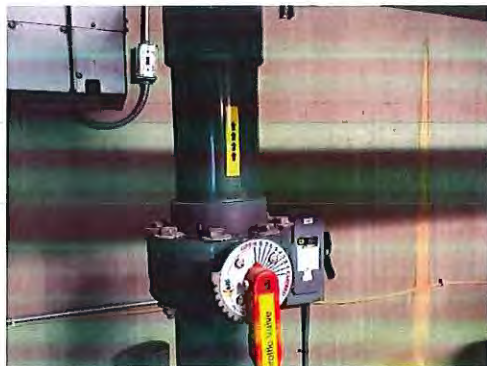
Condition: Good
Priority: Low
Current Code Compliant: No

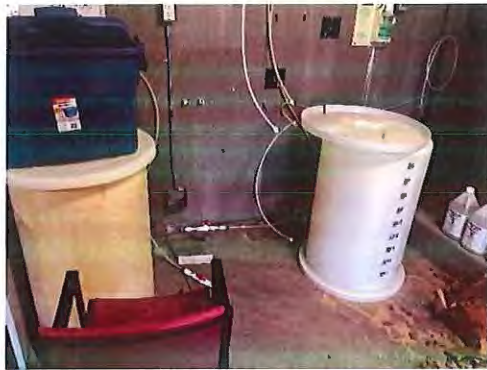
Condition: Good
Priority: Low
Current Code Compliant: Yes

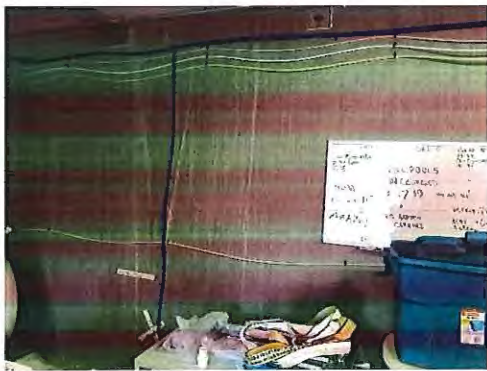
Condition: Good
Priority: Low
Current Code Compliant: Yes

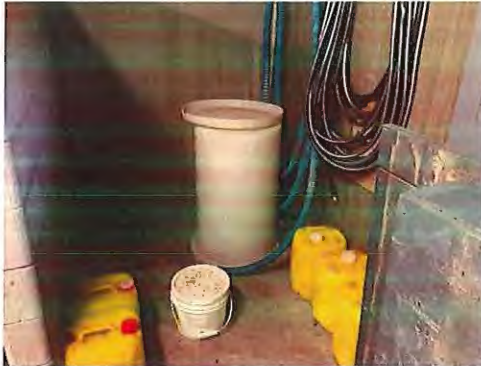
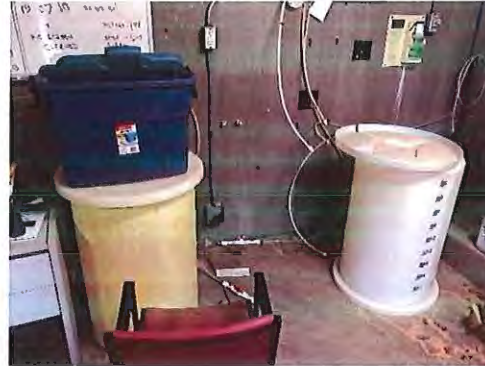
appeared to be in good overall condition, were labeled as required, and were located in different areas of the mechanical room to help avoid accidental confusion of the tanks.

The tanks were not double wall, sealed top containment tanks, and were not vented separately to the exterior. This could create undesired fumes from the tanks to enter the mechanical room and cause corrosion. The room little to no corrosion present in the space itself, so the fumes appear to be under control, so replacing these tanks will be noted as a low priority item.

Condition: Good
Priority: Low
Current Code Compliant: Yes

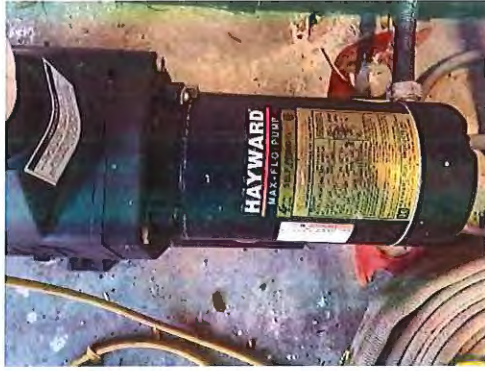
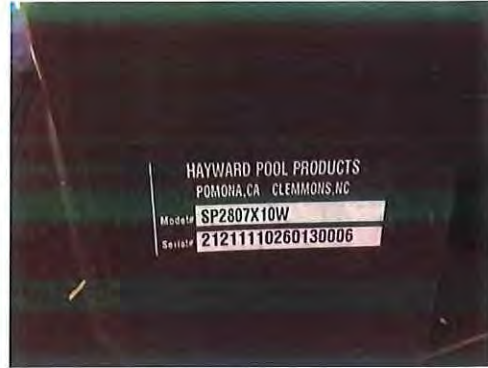
The small pool recirculation pump is a 1HP, 1 Phase, 115/230 V pump, and was noted to be in good condition. Although there was some minor corrosion noted on the motor of the pump, the pump was otherwise noted to be in generally good operating condition.

This pump *should* be large enough to produce the increase flow rate required to meet current code requirements regarding turnover times (47 GPM). This flow rate would need to be tested to ensure the pump is capable.

Condition: Good
Priority: Low
Current Code Compliant: Yes (assumption)

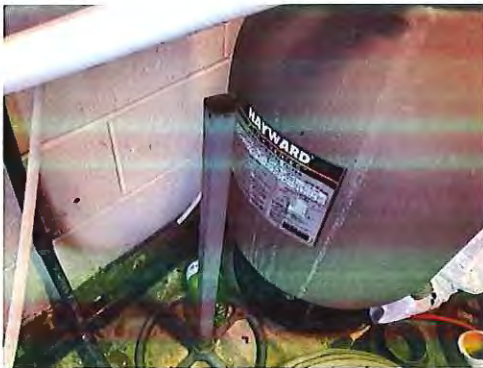
A minimum flow rate of 47 GPM would be required to meet current code and standards for a Wading Pool. If this were the case, the filtration system would need to be upgraded to have a minimum recommendation filter area of 2.75 sq ft, which would achieve a filtration rate of 12.73 GPM / Sq. Ft.

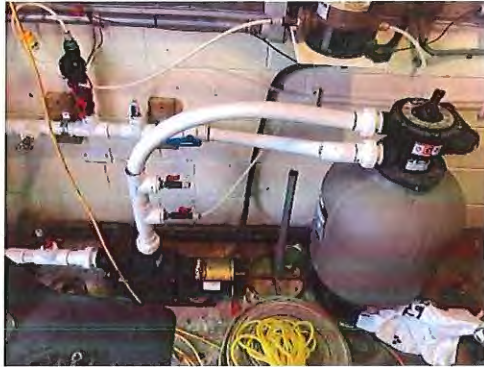
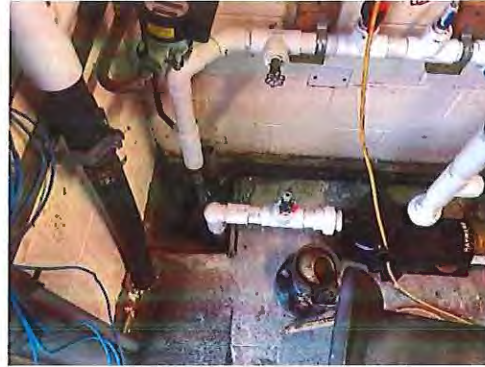
Condition:	Good
Priority:	Low
Current Code Compliant:	No

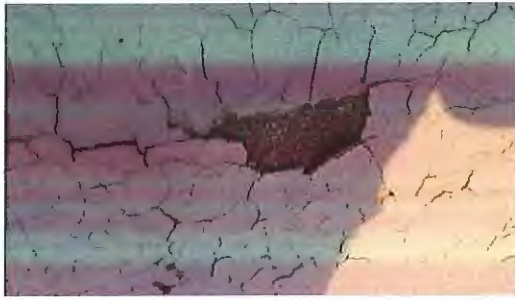
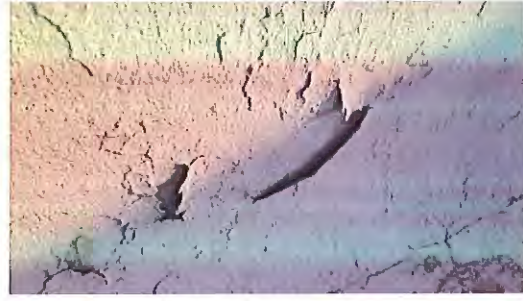
The Large Pool finish was inspected and was noted to be in very poor condition. Large, thick chunks of multiple layers of parge and paint finishes were peeling and flaking off in most locations around the entire pool, on both the walls and floor slab. These chunks were quite sharp in most places and is not providing a proper finish safe for swimming in the pool tank. The entire pool will be required to be hydro blasted down to the base concrete to a proper roughness (as specified by the finishing manufacturer) and a proper Epoxy Paint finish for pools (Tnemec or similar) should be applied to the entire tank, white or light in colour, with proper contrasting markings around drains, steps, and other required areas as per OBC.

Condition:	Poor
Priority:	High
Current Code Compliant:	No

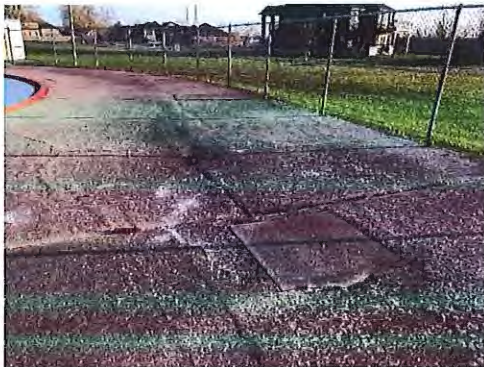
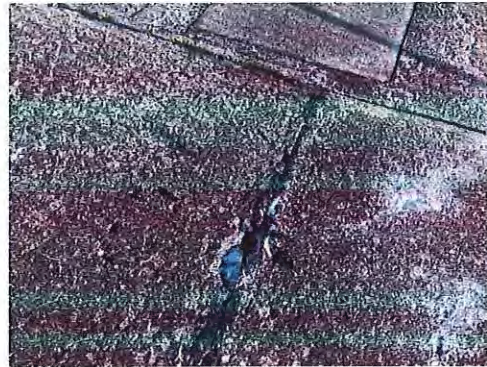
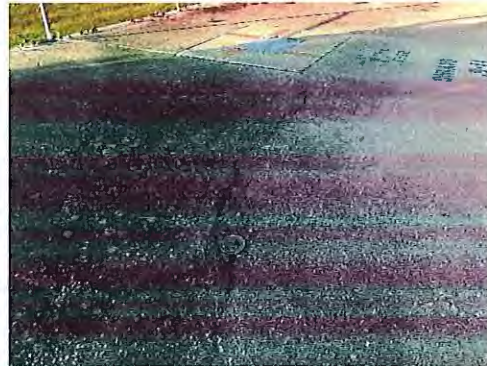
b) DECK CONCRETE FINISH

The Pool concrete deck finish was inspected and was noted to be very uneven in various location around the pool. These conditions create toe stub hazards, fall hazards, and promote water ponding and algae growth.

No (not in all locations)

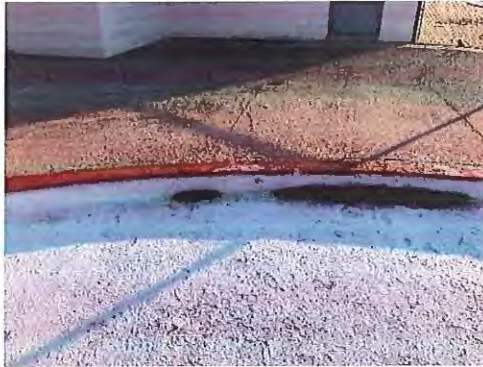
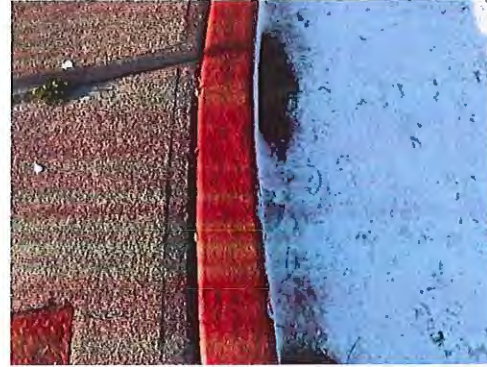
Condition: Poor
Priority: High
Current Code Compliant: No

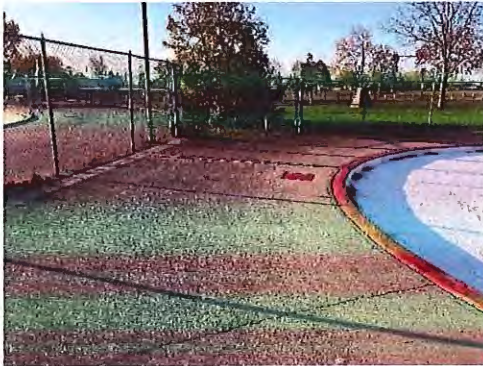
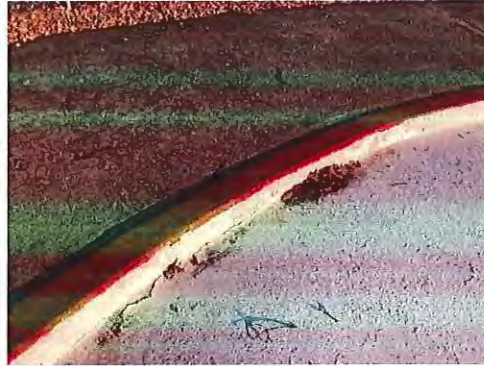
The Small Pool concrete deck finish was inspected and was noted to be in generally good condition. The concrete appeared to be level around the pool, sloping away as required. Minor cracking was noted, but the concrete around the crack did not present any tripping or injury hazards.

Condition: Fair
Priority: Low
Current Code Compliant: Yes

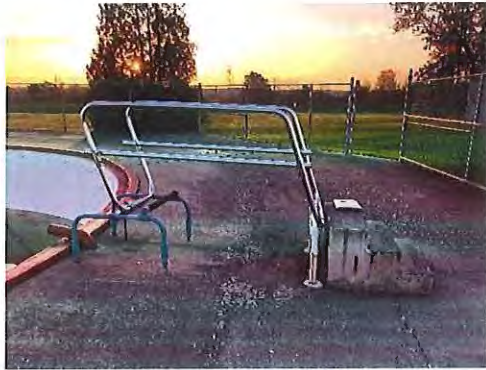
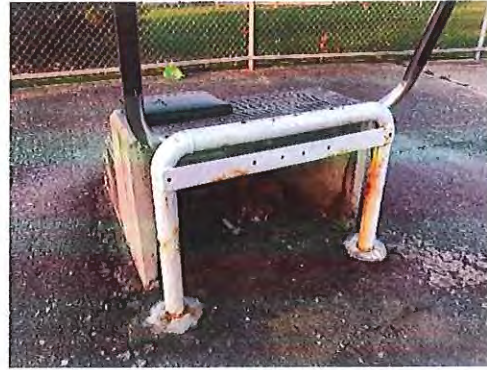
There is a Dive Stand located in the deep end of the Large Pool. The stand was inspected, and though it appeared to be an old/original dive stand base with some minor surface corrosion, overall, the stand appear to be in fair condition. The stainless steel rails mounted to the base were in very good condition, with no corrosion noted. The painted base had some minor corrosion which should be sanded down and repainted to avoid further degradation and staining.

Condition: Fair

Priority: Low
Current Code Compliant: Yes (stand itself)

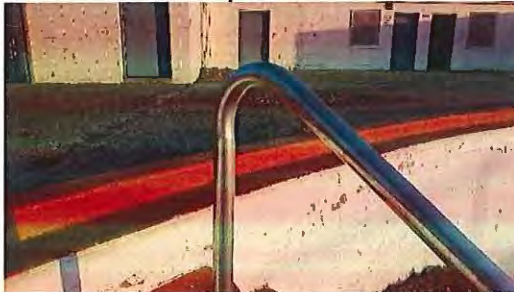
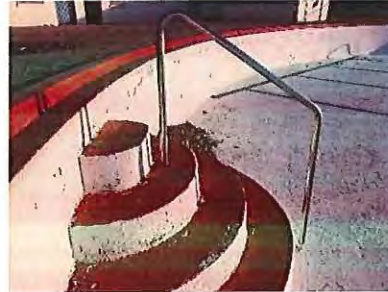
b) STAIR RAILS

There stair rails installed at both sets of steps into the shallow end of the pool. The rails were inspected and appeared to be in overall good condition. There was no corrosion noted at the time of inspection, and the rails were securely embedded into the concrete steps.

Condition: Good
Priority: Low
Current Code Compliant: Yes

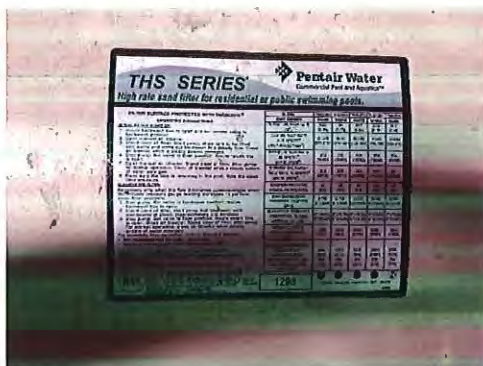
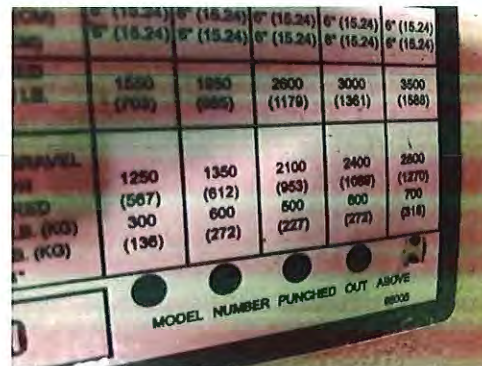
A minimum flow rate of 1600 GPM would be required to meet current code and standards for a Class A Public Pool. If this were the case, the filtration system would need to be upgraded to have a minimum total minimum filter area of 116 sq ft, which would achieve a similar filtration rate of 13.79 GPM / Sq. Ft.

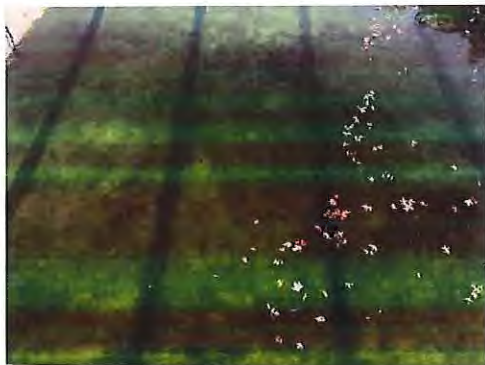
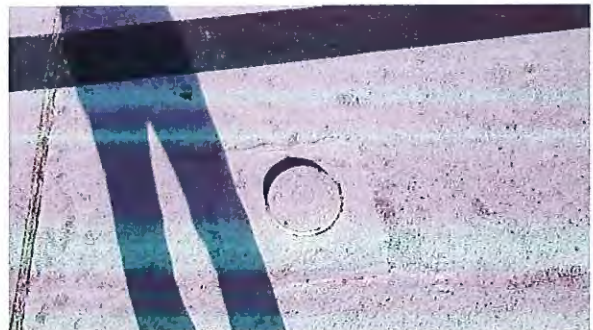
A minimum flow rate of 1600 GPM would be required to meet current code and standards for a Class A Public Pool. If this were the case, the main drain sumps and covers would need to be upgraded to meet the increased suction flow and velocity that would be passing through them. A maximum velocity of 1.5 ft/second is required at both main drains, assuming full flow through each. It would be recommended in this case to abandon the shallow drains (plug and cap) and installed two large 18"x36" VGBA approved sumps and covers in the deep end to replace the current 18"x18" drains.

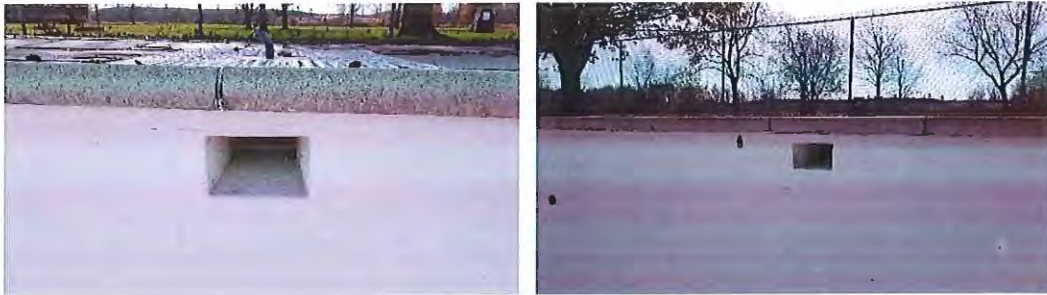
Condition: Good
Priority: High
Current Code Compliant: No (requires skimmer grilles to meet code)

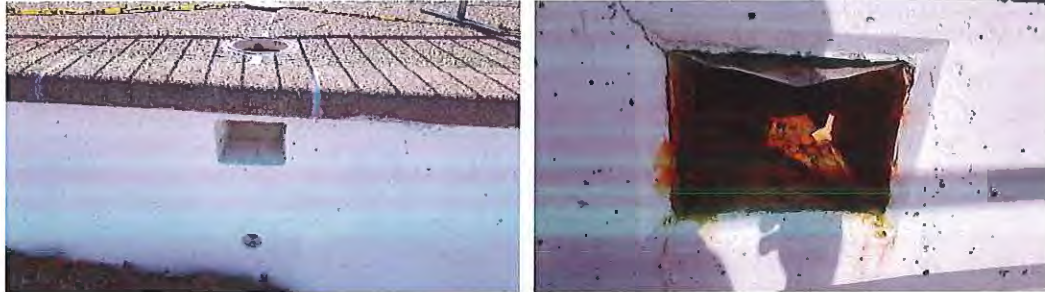
Condition: Good (apart from one skimmer mouth under the ramp)
Priority: High
Current Code Compliant: No (requires skimmer grilles to meet code)

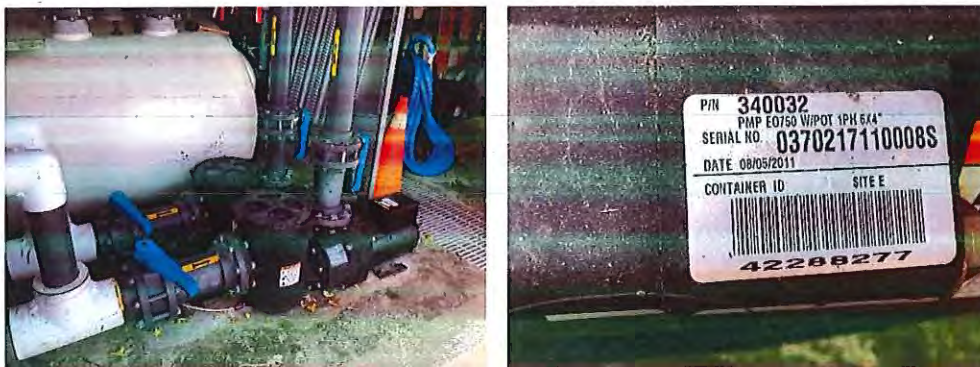
P/N 340032
 PMP E0750 W/POT 1PH 6KA
 SERIAL NO. 0370217110008S
 DATE 08/05/2011
 CONTAINER ID SITE E
 42288277

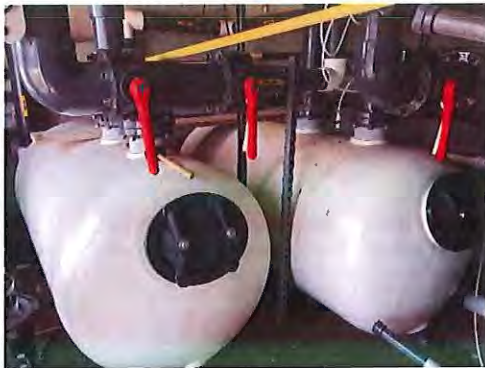
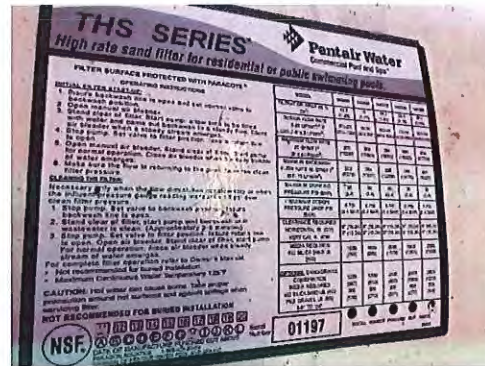
A minimum flow rate of 1600 GPM would be required to meet current code and standards for a Class A Public Pool. If this were the case, the filters would need to be upgraded to have a minimum recommendation filter area of 116 sq ft (total), which would achieve a filtration rate of 13.79 GPM / Sq. Ft

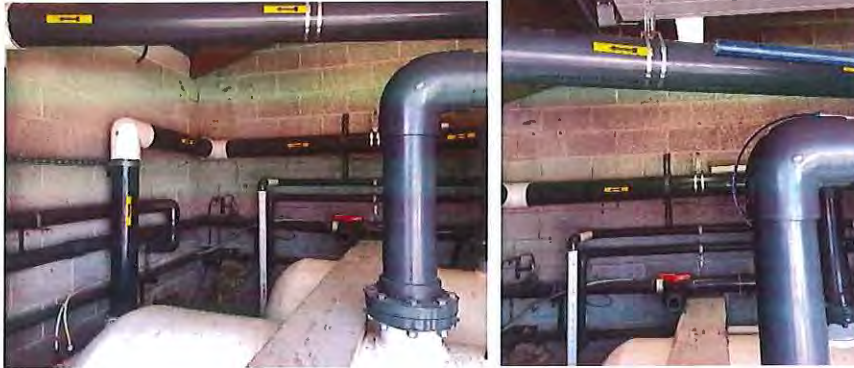
A minimum flow rate of 1600 GPM would be required to meet current code and standards for a Class A Public Pool. If this were the case, the piping would need to be upgraded to meet current code requirements for maximum velocity through piping. 12" suction piping (6 ft/sec) and 10" pressure piping (10 ft/sec) would be required.

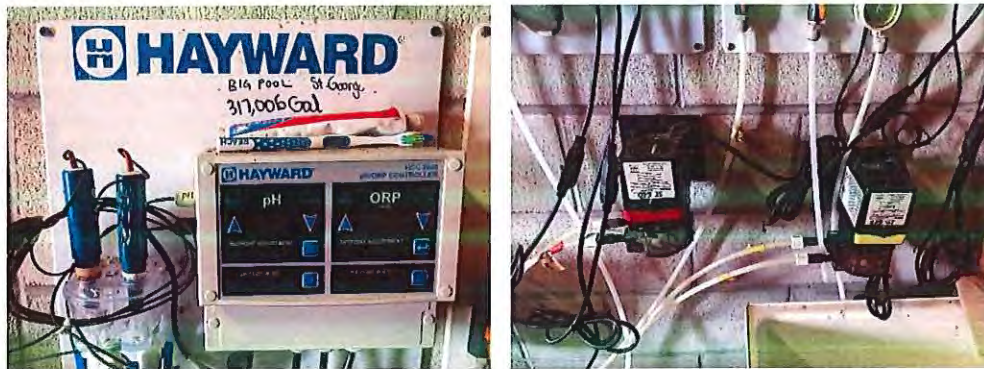
The presence of these feeders and controller meet the OBC requirements of section 3.11.8.1(8), which requires the use of an automatic chemical controller to continuously disinfect the water of a public pool.

Condition:	Good
Priority:	Low
Current Code Compliant:	Yes

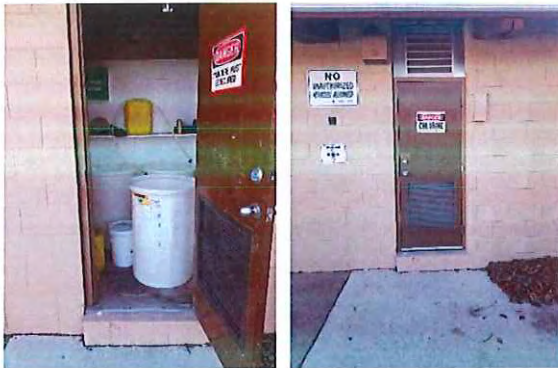
The tanks were not double wall, sealed top containment tanks, and were not vented separately to the exterior. This could create undesired fumes from the tanks to enter the mechanical room and cause corrosion. The room little to no present in the space itself, so the fumes appear to under control, so replacing these tanks will be noted as a low priority item.

Condition:	Good
Priority:	Low
Current Code Compliant:	Yes

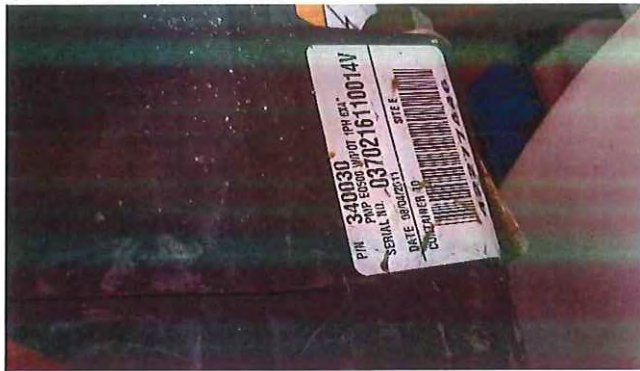
The small pool recirculation pump is a 5HP, 1 Phase, 230 V pump, and was noted to be in good condition. Although there was some minor corrosion noted on the motor of the pump, the pump was otherwise noted to be in generally good operating condition.

Condition:	Good
Priority:	Low
Current Code Compliant:	Yes

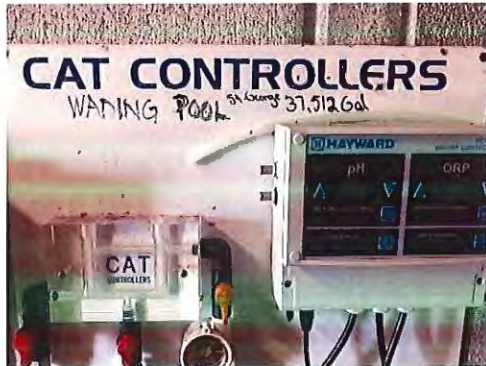
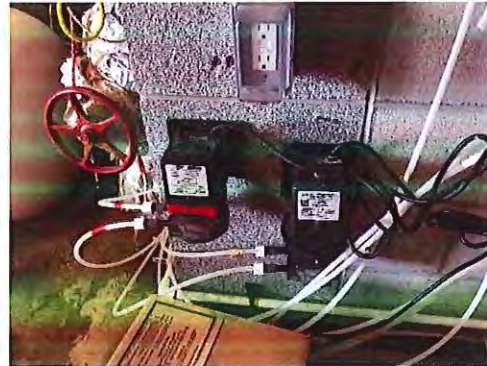
d) AUTOMATIC CHEMICAL CONTROLLER

The small pool sanitation system is operated by an Automatic Chemical controller. The system had been winterized but was noted by staff to be in good operational condition. There are also automatic feeds pumps that were being controlled by the chemical controller, which has also been winterized, but were noted to be in good operation condition.

The presence of these feeders and controller meet the OBC requirements of section 3.11..8.1(8), which requires the use of an automatic chemical controller to continuously disinfect the water of a public pool.

Condition:	Good
Priority:	Low
Current Code Compliant:	Yes

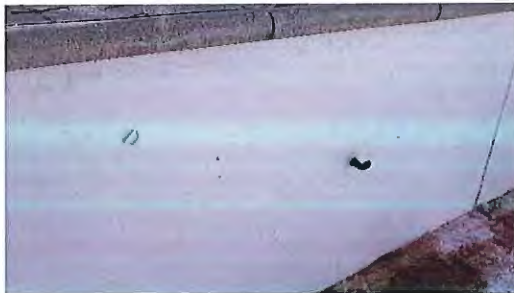
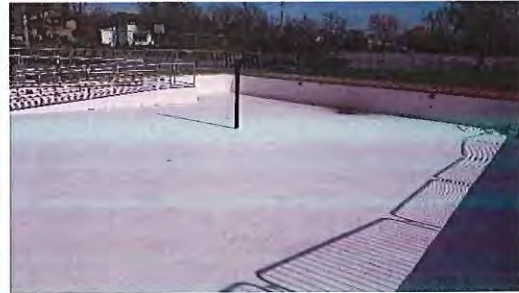
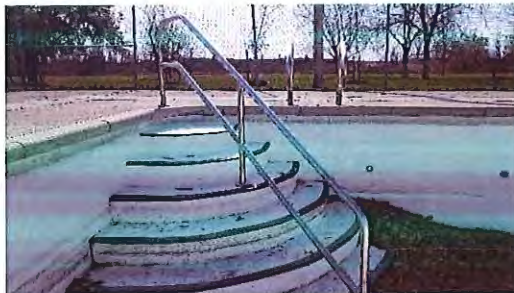
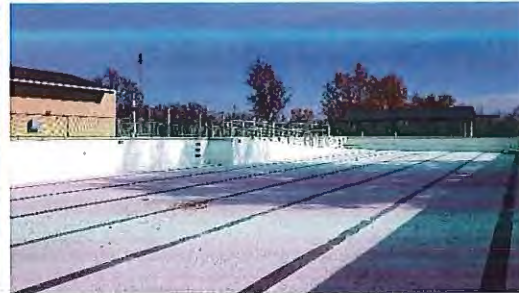
The Large Pool finish was inspected and was noted to be in very good overall condition. An Epoxy Paint finish appears to have been applied at this location applied to the entire tank and is light in color with proper contrasting markings around drains, steps, and other required areas as per OBC.

Condition: Good
Priority: Low
Current Code Compliant: Yes

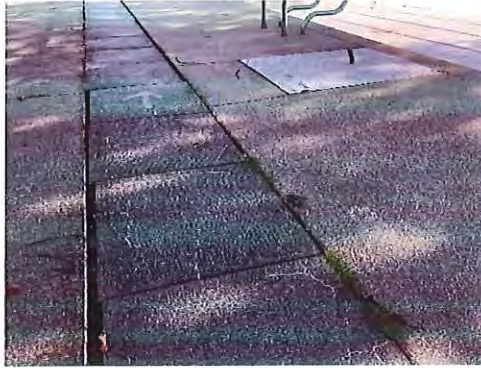
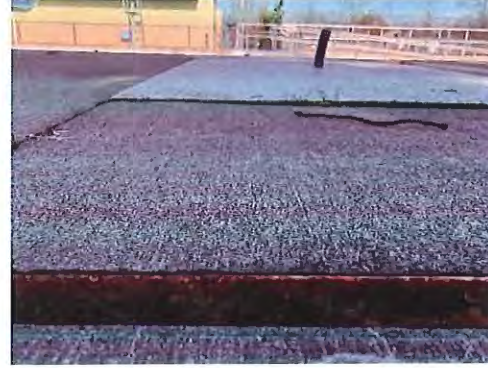
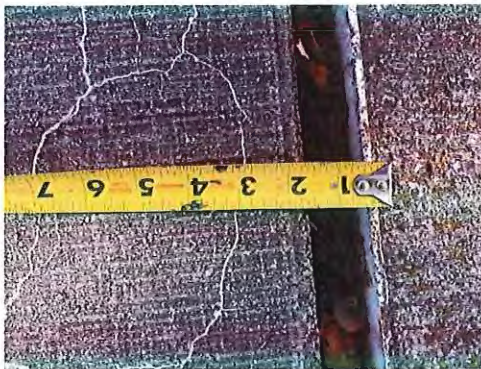
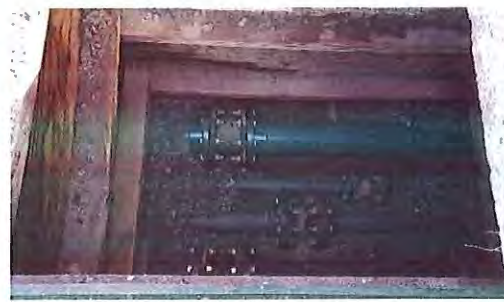
The existing deck does not provide proper slope off of the deck at all locations. The existing water will run down into the piping trench, which in turn creates further erosion of the area.

Condition: Poor
Priority: Medium
Current Code Compliant: No (not in all locations)

- 1) The Pool concrete deck finish was inspected and was noted to be very uneven in various location around the pool, specifically due to the paver stones covering the buried piping. These stones and supports have sunk slightly over time and have created large gaps (up to 2" in some locations) and uneven conditions all around the pool deck. These conditions create toe stub hazards, fall hazards, and promote water ponding and algae growth. The existing deck does not provide proper slope off of the deck at all locations. It is recommended that the supporting system of the deck pavers is re-worked to ensure the pavers themselves are suiting flush with the surrounding deck, and that there are no large gaps between the supports, the pavers, and the existing deck.

Overall Recommended Priority: Medium

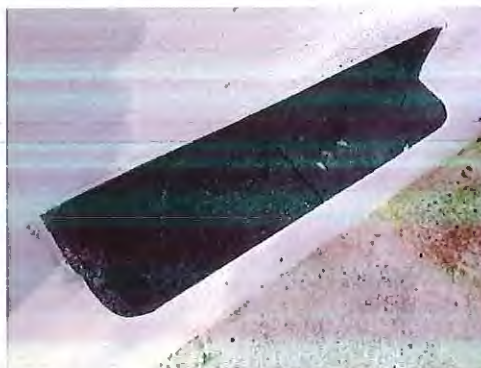
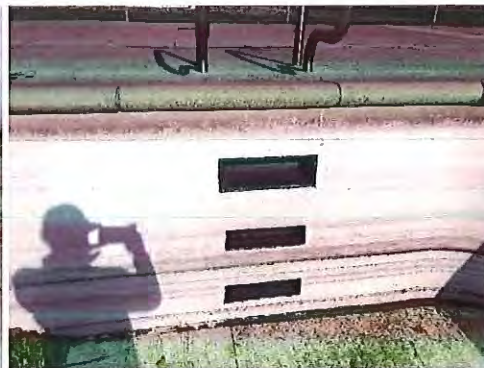
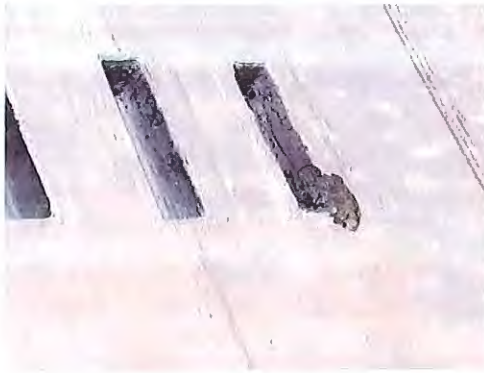
c) POOL TANK RECESSED STEPS

The large Pool had seven (7) three-tread recessed steps with grab rails located around the pool perimeter. The grab rails themselves were in good conditions, with no noted issues. The recessed steps were cracked and peeling in most locations, and presented as a potential injury issue due to this. It is recommended that the recessed steps are chipped out, removed, and replaced with new to avoid potential injury on these steps.

Condition: Poor
Priority: Medium
Current Code Compliant: Yes

- 2) The large Pool had seven (7) three-tread recessed steps with grab rails located around the pool perimeter. The grab rails themselves were in good conditions, with no noted issues. The recessed steps were cracked and peeling in most locations, and presented as a potential injury issue due to this.

It is recommended that the recessed steps are chipped out, removed, and replaced with new to avoid potential injury on these steps.

Overall Recommended Priority: Medium

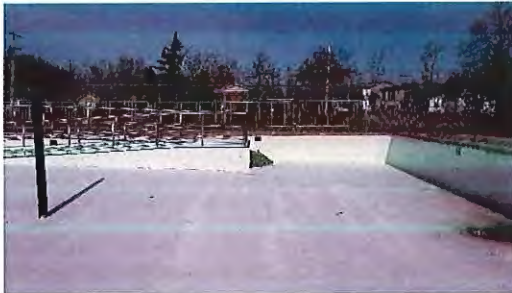
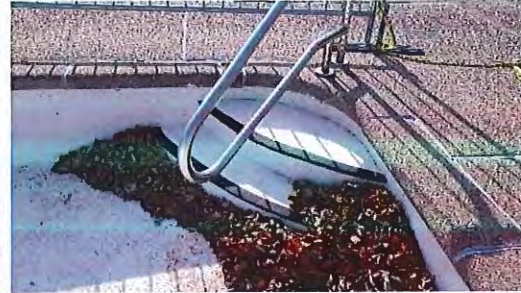
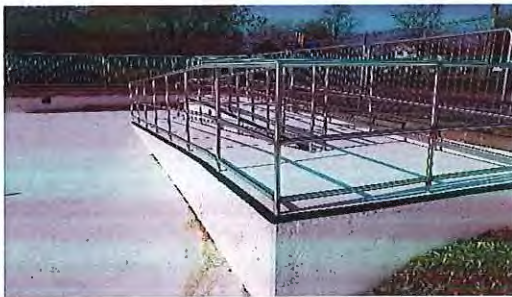
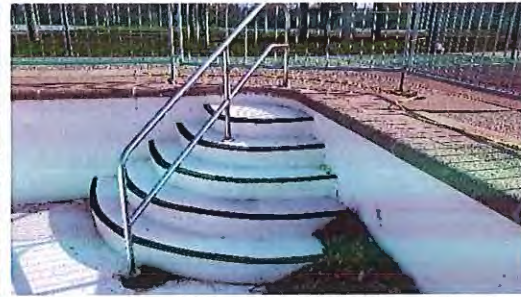
d) TANK PAINT FINISH

The Small Pool finish was inspected and was noted to be in very good overall condition. An Epoxy Paint finish appears to have been applied at this location applied to the entire tank and is light in color with proper contrasting markings around drains, steps, and other required areas as per OBC.

Condition:	Good
Priority:	Low
Current Code Compliant:	Yes

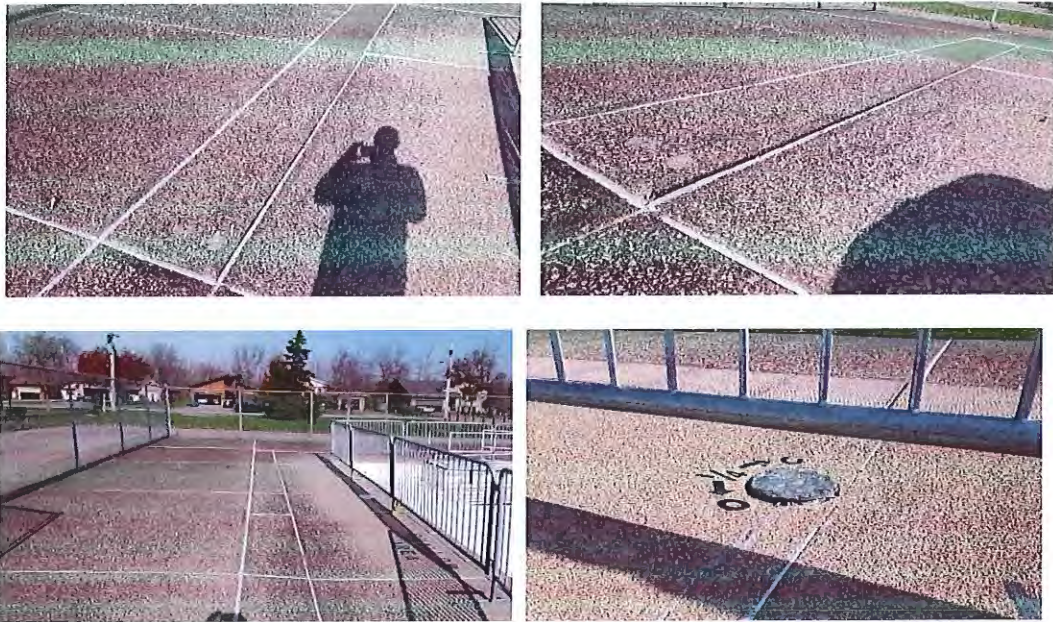
e) DECK CONCRETE FINISH

The Small Pool concrete deck finish was inspected and was noted to be in generally good condition. The concrete appeared to be level around the pool, sloping away as required. Minor shifting and movement was noted, but the concrete around the crack did not present any tripping or injury hazards, and the joints were all well caulked.

Condition:	Good
Priority:	Low
Current Code Compliant:	Yes

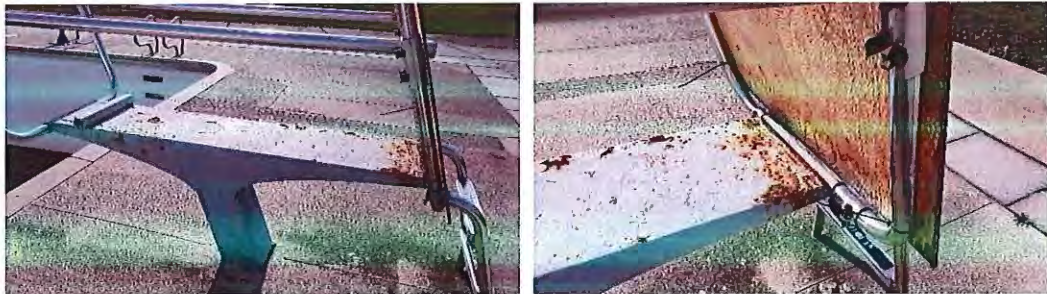
a) DIVE STAND

There is a Dive Stand located in the deep end of the Large Pool. The stand was inspected, and though it appeared to be an old/original dive stand base with some minor surface corrosion, overall, the stand appears to be in fair condition. The stainless steel rails mounted to the base were in very good condition, with no corrosion noted. The painted base had some minor corrosion which should be sanded down and repainted to avoid further degradation and staining.

Condition:	Fair
Priority:	Low
Current Code Compliant:	Yes (stand itself)

- 1) There is a Dive Stand located in the deep end of the Large Pool. The stand was inspected, and though it appeared to be an old/original dive stand base with some minor surface corrosion, overall, the stand appears to be in fair condition. The stainless steel rails mounted to the base were in very good condition, with no corrosion noted. The painted base had some minor corrosion which should be sanded down and repainted to avoid further degradation and staining.

Overall Recommended Priority: Low

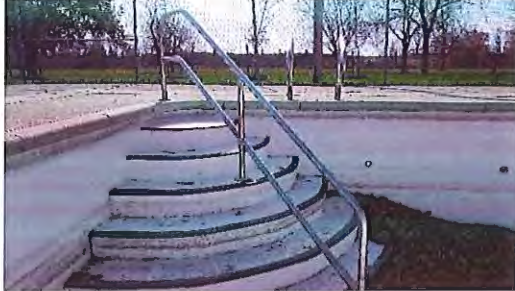
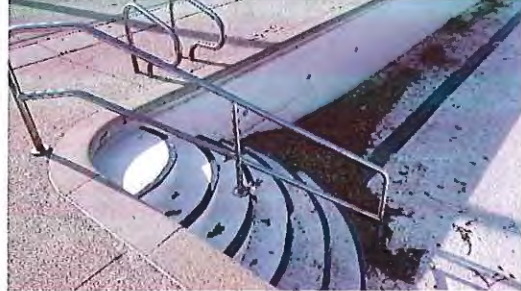
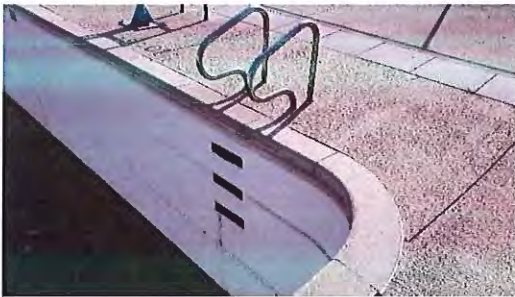
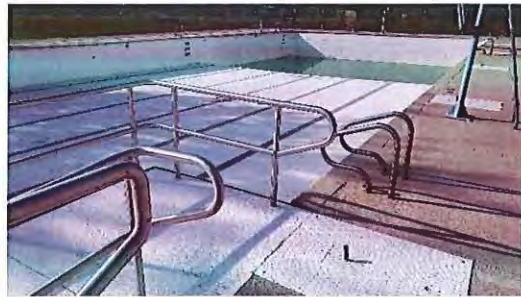
b) STAIR/RAMP RAILS

There were stair rails installed at the shallow end sets of steps into the pool. The rails were inspected and appeared to be in overall good condition. There was no corrosion noted at the time of inspection, and the rails were securely embedded into the concrete steps.

There were also ramp and deck rails installed at the accessibility ramp into the pool. The ramp and deck rails were inspected and appeared to be in overall good condition. There was no corrosion noted at the time of inspection, and the rails were securely embedded into the concrete steps.

There were also grab rails located around the deck for the recessed/embedded ladder treads. These rails were also in good overall condition. It was noted however that one grab rail (by the

entry steps has become obsolete and should be removed to prevent patrons from swinging on it, and to allow more room and the entry to the steps.

Condition: Good
Priority: Low
Current Code Compliant: Yes

- 2) It was noted that one grab rail (by the entry steps in the shallow end) has become obsolete and should be removed to prevent patrons from swinging on it, and to allow more room and the entry to the steps.

Overall Recommended Priority: Low

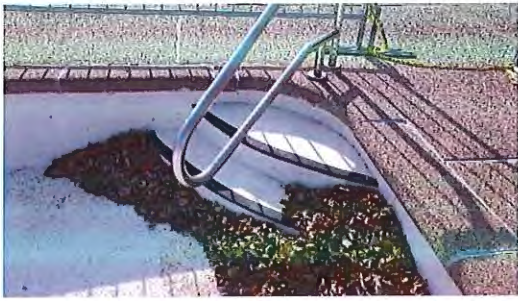
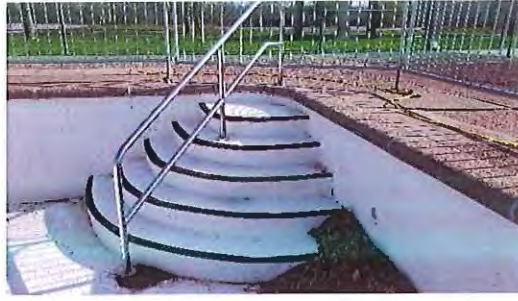
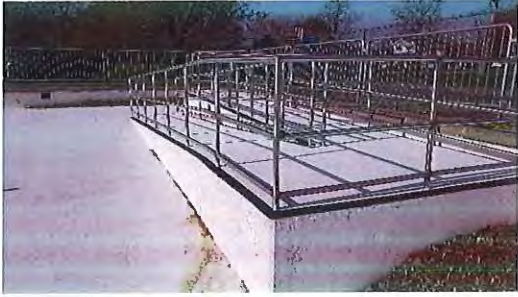
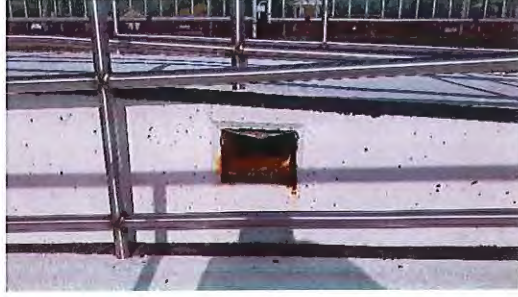
a) STAIR/RAMP RAILS

There were stair rails installed at the shallow end sets of steps into the pool. The rails were inspected and appeared to be in overall good condition. There was no corrosion noted at the time of inspection, and the rails were securely embedded into the concrete steps.

There were also ramp and deck rails installed at the accessibility ramp into the pool. The ramp and deck rails were inspected and appeared to be in overall good condition. There was no corrosion noted at the time of inspection, and the rails were securely embedded into the concrete steps.

There were also grab rails located around the deck for the recessed/embedded ladder treads. These rails were also in good overall condition. It was noted however that one grab rail (by the entry steps has become obsolete and should be removed to prevent patrons from swinging on it, and to allow more room and the entry to the steps.

Condition: Good
Priority: Low
Current Code Compliant: Yes

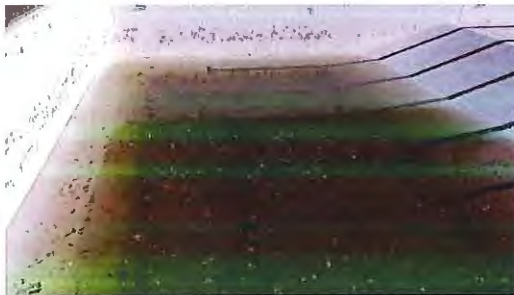
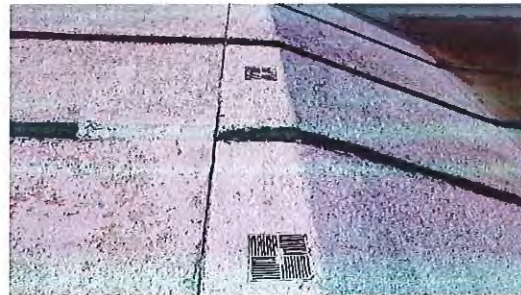
There are three 12"x12" pool main drains noted by staff in the deep end of the pool. We were visually unable to inspect these drains, as they were underwater and covered in leaves. The three main drains were noted to be not properly spaced as per OBC requirements (4' minimum from edge to edge of cover grate). Current industry safety standards regarding main drain anti-entrapment require pools to have anti-entrapment "unblockable" drain covers installed. An "Unblockable drain" includes a suction outlet defined as all components, including the sump and/or body, cover/grate, and hardware such that its perforated (open) area cannot be shadowed by the area of the 18"x23" Body Blocking Element of ASME/ANSI A112.19.8-2007.

Condition:	Deep End - Unable to Verify Shallow End - Poor
Priority:	Deep End - High (if not "Unblockable") Shallow End - High
Current Code Compliant:	Deep End - Unable to Verify Shallow End - No

A minimum flow rate of 1600 GPM would be required to meet current code and standards for a Class A Public Pool. If this were the case, the main drain sumps and covers would need to be upgraded to meet the increased suction flow and velocity that would be passing through them. A maximum velocity of 1.5 ft/second is required at both main drains, assuming full flow through each. It would be recommended in this case to abandon the shallow drains (plug and cap) and install two large 18"x36" VGBA approved sumps and covers in the deep end to replace the current 12"x12" drains.

- 2) The existing mains drain covers in the deep portion of the pool are to be inspected, and if they are below the size of 23" x 18" (each) and not domed, these drain covers are to be replaced with Unblockable domed drain covers. This will ensure all current code, safety, and industry standards are being met regarding main drain anti-entrapment conditions.

Overall Recommended Priority: High (If not domed "unblockable")

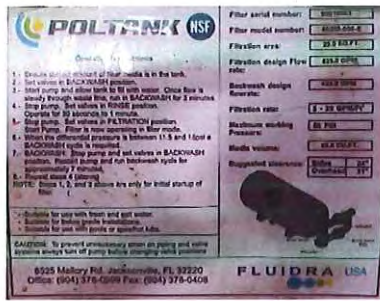
Condition: Good
Priority: Low
Current Code Compliant: Yes

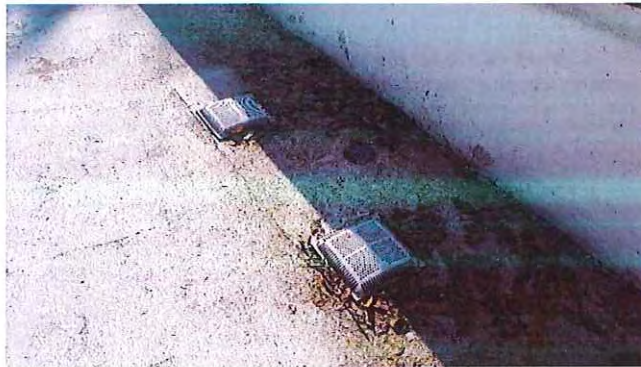
c) MAIN DRAIN:

There were two 12"x12" Unblockable drains installed at the time of inspection within the small pool. The drains appeared to have been recently installed and were in good operating condition.

The existing drains did not have a contrasting band painted around them.

Condition:	Good
Priority:	Low
Current Code Compliant:	No (just missing contrasting band)

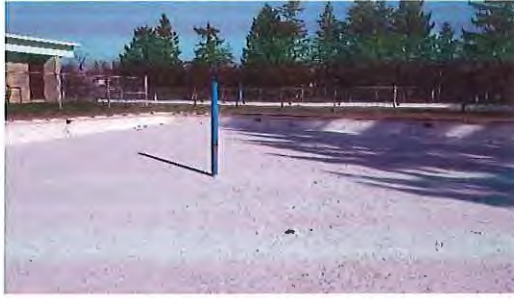
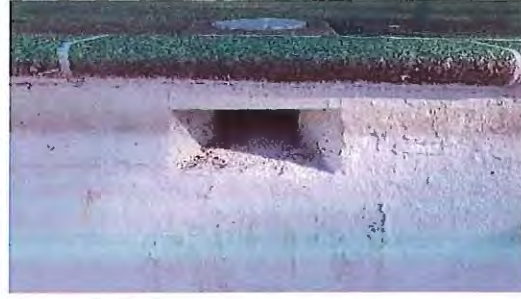
d) SKIMMERS

This pool is currently operating as a skimmer recirculation system, with 8 skimmers located around the perimeter of the tank. The skimmers installed did not have skimmer mouth covers installed. As per OBC section 3.11.8.1(14), "*...all fitting at or below the water surface that allow water and/or air to be passed to or from the public pool shall,*

This system is currently providing adequate cleaning the way of surface skimming, under the current flow rate.

Condition:	Good
Priority:	High
Current Code Compliant:	No (requires skimmer grilles to meet code)

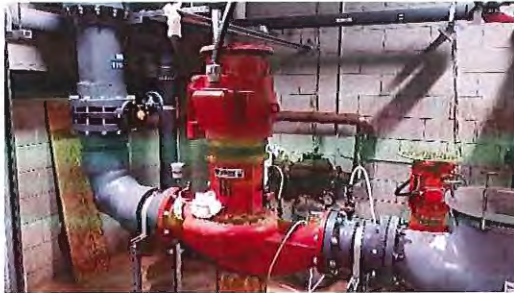
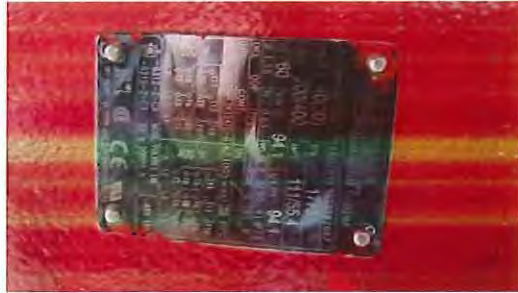
a) PUMP

This pump would be large enough to produce the increase flow rate required to meet current code requirements regarding turnover times (1600 GPM), and the VFD would simply need to be reprogrammed to increase the flow rate.

Condition:	Good
Priority:	Low
Current Code Compliant:	Yes

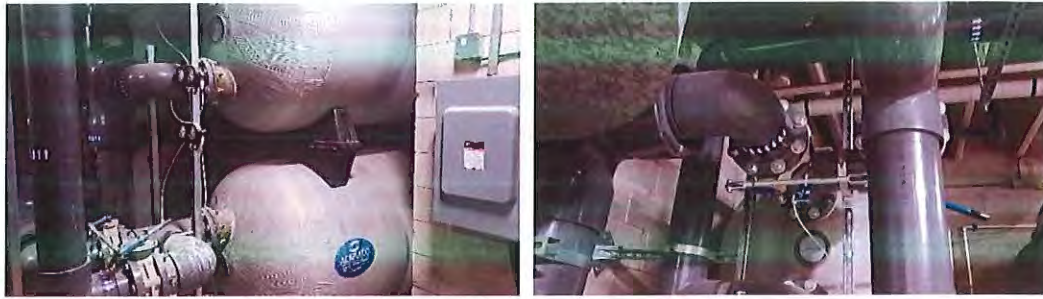
FILTERS

The pool filtration system consists of four (4) Fluidra 48290-050 Horizontal Pressure Sand Filters, which have a combined filtration area of 116.0 sq ft. and are rated for a maximum 435 GPM flow rate each.

A minimum flow rate of 1600 GPM would be required to meet current code and standards for a Class A Public Pool. If this were the case, the existing filtration system has been sized to accommodate this, and would achieve a filtration rate of 13.79 GPM / Sq. Ft. (Refer to Table A)

Condition:	Good
Priority:	Low
Current Code Compliant:	Yes
