GENERAL COMMITTEE

Tuesday, January 26, 2021
Meeting Number 2021 – 01

SUBJECT: OUTDOOR POOL CONDITION ASSESSMENT

Pool Condition Assessment

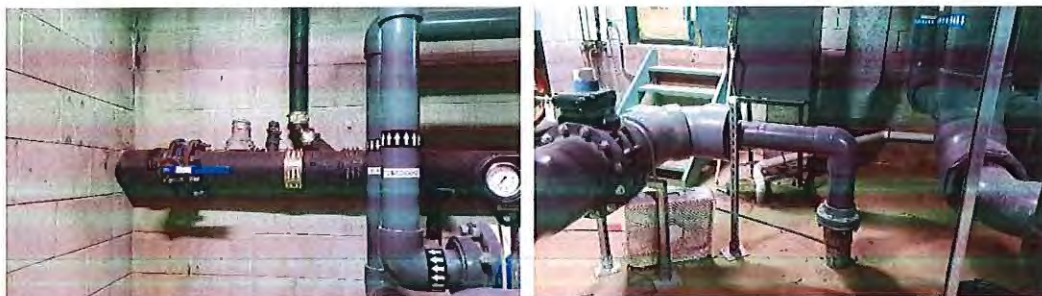
b) PIPING, SUPPORTS, VALVES

All piping was visually inspected for the pool, along with piping supports, connections, and valves.

A minimum flow rate of 1600 GPM would be required to meet current code and standards for a Class A Public Pool. If this were the case, all buried piping would need to be upgraded to meet current code requirements for maximum velocity through piping. 12" suction piping (6 ft/sec) and 10" pressure piping (10 ft/sec) would be required. The existing exposed piping in the mechanical has already been upgraded to meet this requirement.

Condition:	Good
Priority:	Low
Current Code Compliant:	Exposed – Yes
	Buried - No

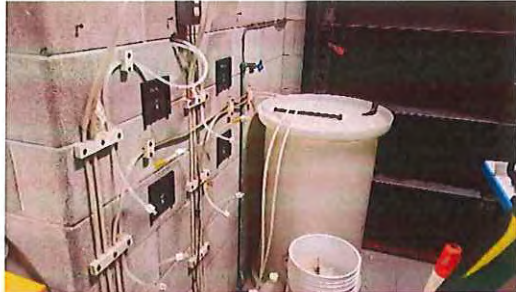
c) AUTOMATIC CHEMICAL CONTROLLER

The pool sanitation system is operated by an Automatic Chemical ORP/PH digit controller. The system had been winterized, but was noted by staff to be in good operational condition. There are also automatic feeds pumps that were being controlled by the chemical controller, which has also been winterized, but were noted to be in good operation condition.

The presence of these feeders and controller meet the OBC requirements of section 3.11.8.1(8), which requires the use of an automatic chemical controller to continuously disinfect the water of a public pool.

Condition: Good
Priority: Low
Current Code Compliant: Yes

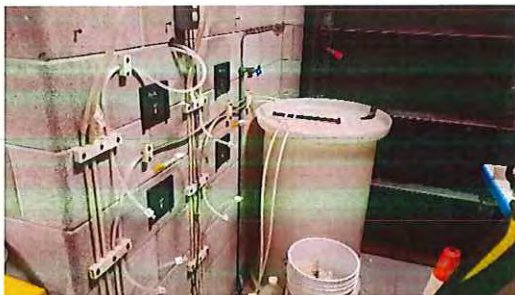
The tanks were not double wall, sealed top containment tanks, and were not vented separately to the exterior. This could create undesired fumes from the tanks to enter the mechanical room and cause corrosion. The room had little to no corrosion present in the space itself, so the fumes appear to be under control, so replacing these tanks will be noted as a low priority item.

Condition: Good
Priority: Low
Current Code Compliant: Yes

- 3) Installing closed top chemical tanks, vented to the exterior of the building, would help eliminate harmful fumes being released or leaking out into the mechanical space. These fumes will cause corrosion to form on metallic items within the pool equipment room, such as pumps, electrical panels, conduits, pipe supports, etc., and decrease these items lifespan.

Overall Recommended Priority: Low

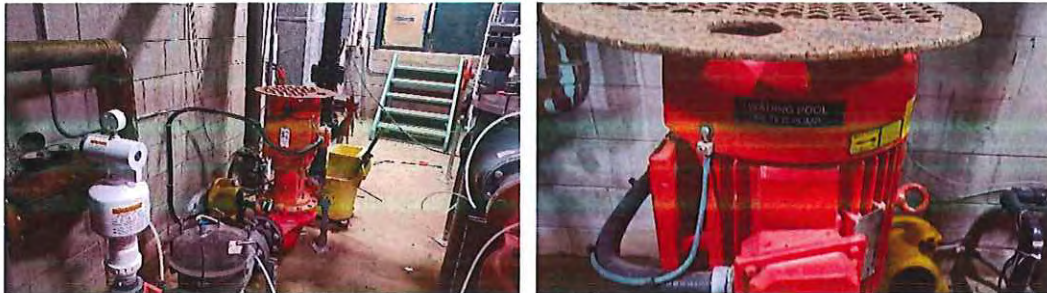
The small pool recirculation pump is a 10HP, 3 Phase, 208 V pump connected to a VFD, and was noted to be in good condition, and was installed 4 year prior. This pump is currently producing a code complaint flow rate.

Condition: Good
Priority: Low
Current Code Compliant: Yes

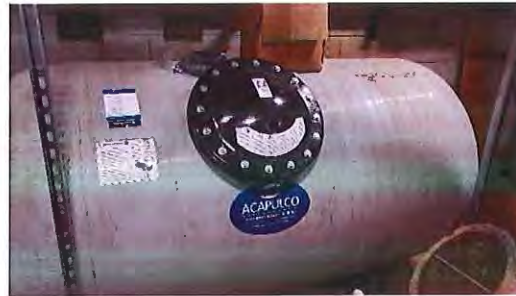
b) FILTERS

The small pool filter system consists of one (1) Fluidra 45290-050 Horizontal Pressure Sand Filter, which has a filtration area of 29 sq ft. and are rated for a maximum 435 GPM flow rate maximum.

The filter tank itself, as well as the related face piping, are in good physical condition and were noted by staff to be in good operational condition.

Condition: Good
Priority: High
Current Code Compliant: Yes

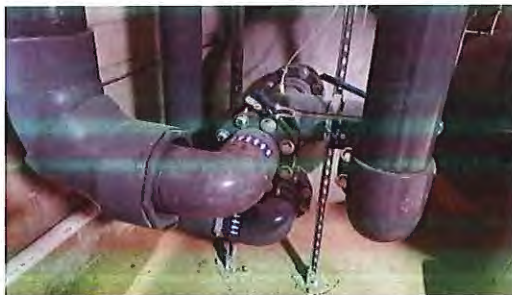
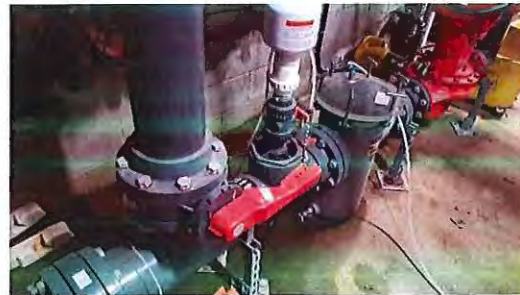
c) PIPING, SUPPORTS, VALVES

All piping was visually inspected for the pool, along with piping supports, connections, and valves.

Valves tags were present.

Condition:	Good
Priority:	Low
Current Code Compliant:	Yes

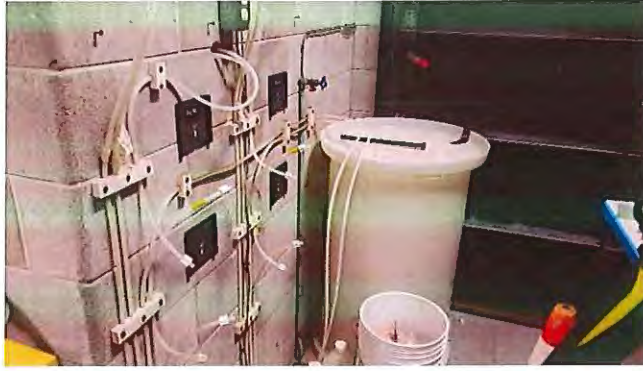
d) AUTOMATIC CHEMICAL CONTROLLER

The small pool sanitation system is operated by an Automatic Chemical controller. The system had been winterized but was noted by staff to be in good operational condition. There are also automatic feeds pumps that were being controlled by the chemical controller, which has also been winterized, but were noted to be in good operation condition.

The presence of these feeders and controller meet the OBC requirements of section 3.11..8.1(8), which requires the use of an automatic chemical controller to continuously disinfect the water of a public pool.

Condition:	Good
Priority:	Low
Current Code Compliant:	Yes

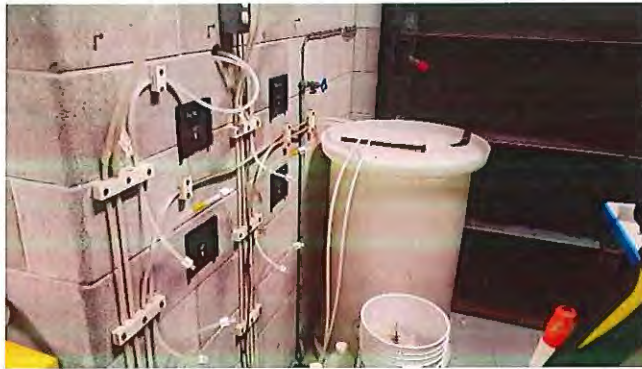
e) CHEMICAL FEED LINES / SAMPLE LINES

The chemical feed lines consist of poly tubing for each of the sample line and chlorine feed line. The tubing is properly connected to the recirculation system and appears to be in good condition.

Condition:	Good
Priority:	Low
Current Code Compliant:	Yes

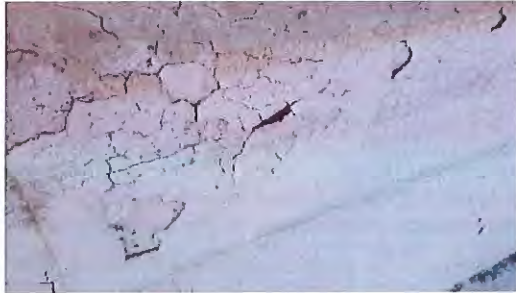
The Large Pool finish was inspected and was noted to be in fair to poor overall condition. A type of Paint finish, along with a parge coat, appears to have been applied at this location to the entire tank. The paint/parge coat is peeling off in large chunks at various locations around the pool tank. The finish is light in color with most of the proper contrasting markings around steps, and other required areas as per OBC.

Condition: Poor
Priority: High
Current Code Compliant: Yes

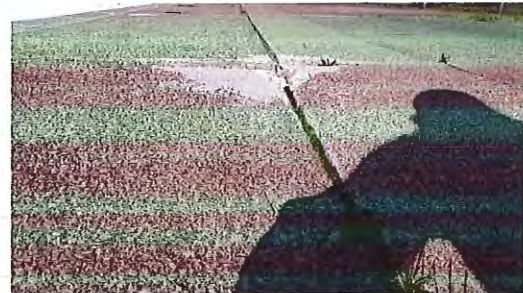
b) DECK CONCRETE FINISH

The Pool concrete deck finish was inspected and was noted to be in generally good condition, with the exceptions of some uneven areas in various location around the pool. These uneven conditions create toe stub hazards, fall hazards, and promote water ponding and algae growth.

Condition: Fair
Priority: Low
Current Code Compliant: Yes

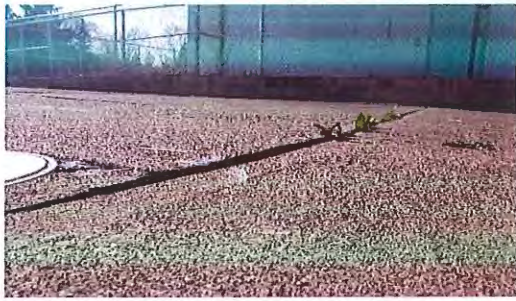
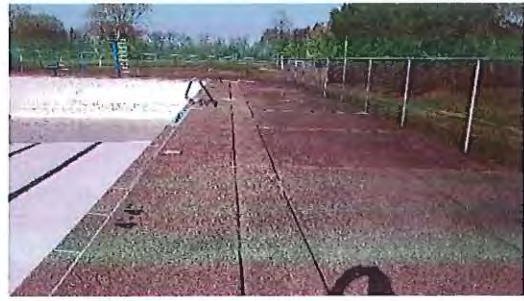
c) POOL TANK RECESSED STEPS

The large Pool had eight (8) three-tread recessed steps with grab rails located around the pool perimeter. The grab rails themselves were in good conditions, with no noted issues. The recessed steps were cracked and peeling in most locations, and presented as a potential injury issue due to this.

Condition: Poor
Priority: Medium
Current Code Compliant: Yes

It is recommended that the recessed steps are chipped out, removed, and replaced with new to avoid potential injury on these steps.

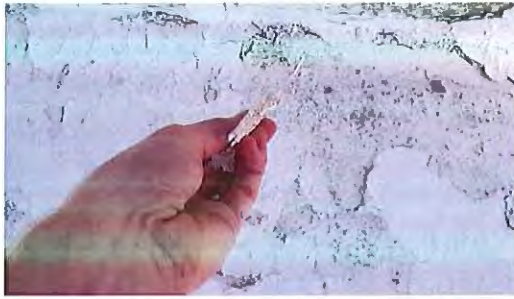
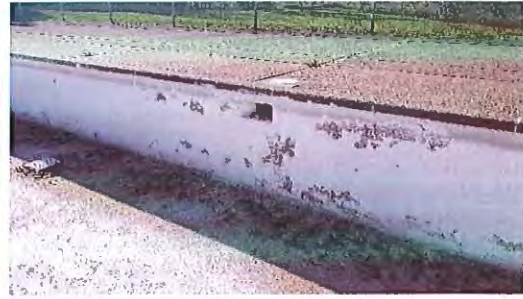
d) TANK PAINT FINISH

The Small Pool finish was inspected and was noted to be in fair to poor overall condition. A type of Paint finish, along with a parge coat, appears to have been applied at this location to the entire tank. The paint/parge coat is peeling off in large chunks at various locations around the pool tank. The finish is light in color with most of the proper contrasting markings around steps, and other required areas as per OBC.

Condition: Poor
Priority: High
Current Code Compliant: Yes

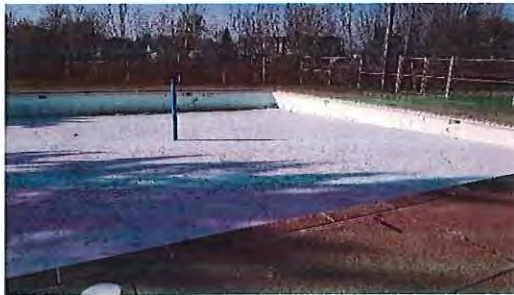
e) DECK CONCRETE FINISH

The Small Pool concrete deck finish was inspected and was noted to be in generally good condition. The concrete appeared to be level around the pool, sloping away as required. Minor shifting and movement was noted, but the concrete around the crack did not present any tripping or injury hazards, and the joints were all well caulked.

Condition:	Good
Priority:	Low
Current Code Compliant:	Yes

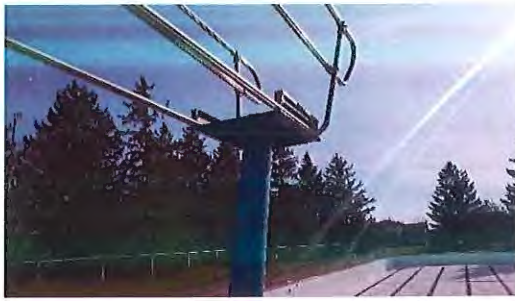
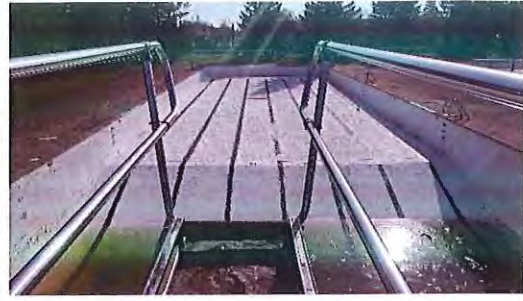
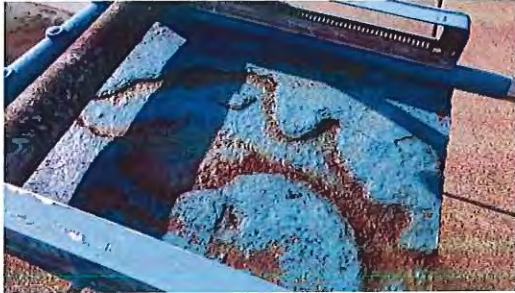
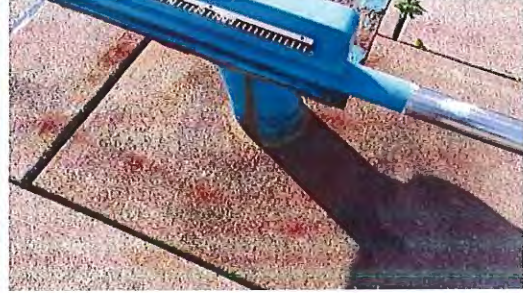
a) DIVE STANDS

There were two Dive Stands located in the deep end of the Large Pool. The stands were inspected, and though they appeared to be an old/original dive stand base with some minor surface corrosion, overall, the stand appears to be in fair condition. The stainless steel rails mounted to the base were in very good condition, with no corrosion noted. The painted base had some minor corrosion which should be sanded down and repainted to avoid further degradation and staining.

Condition:	Fair
Priority:	Low
Current Code Compliant:	Yes (stand itself)

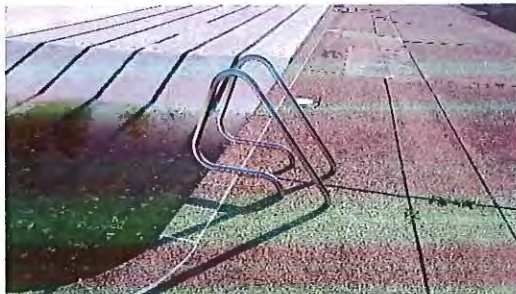
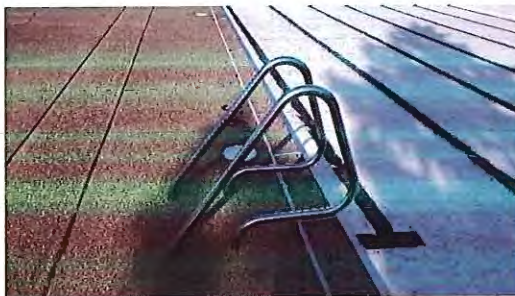
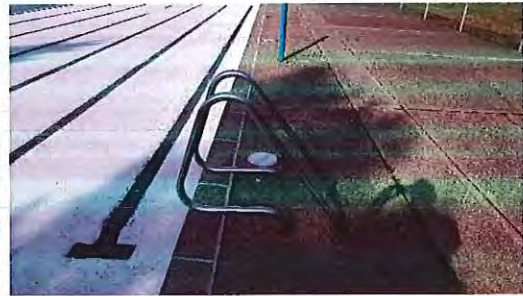
b) GRAB RAILS

There were grab rails located around the deck for the recessed/embedded ladder treads. These rails were also in good overall condition.

There were no entry steps or ramps at this location.

Condition: Good
Priority: Low
Current Code Compliant: Yes
