Preliminary Phase One Environmental Site Assessment

555 Canal Bank Street, Welland, Ontario

HAM-00801631-A0

March 29, 2019

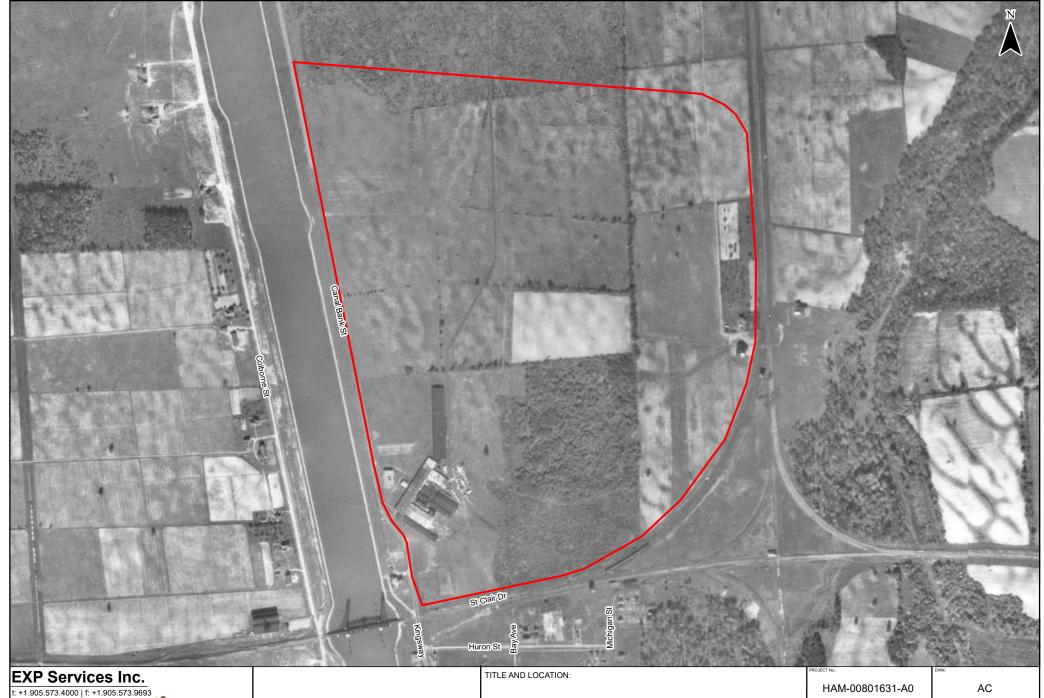
PROJECT No.:	DWN:
HAM-00801631-A0	AC
SCALE:	CHKD:
AS NOTED	SH
DATE:	FIG. No.:
MARCH 2019	H1

Aerial Photograph	Details
1934	 The southwest portion of the Site is occupied by an industrial operation which consists of several rectangular shaped buildings surrounding an irregular shaped building. A farmstead is situated on the eastern portion of the Site. A woodlot is observed on the south portion of the Site, and along the northern boundary.
	 The remaining areas of the Site appear to be agricultural land.
	 A rail line is seen south adjacent to the Site and curves northward,

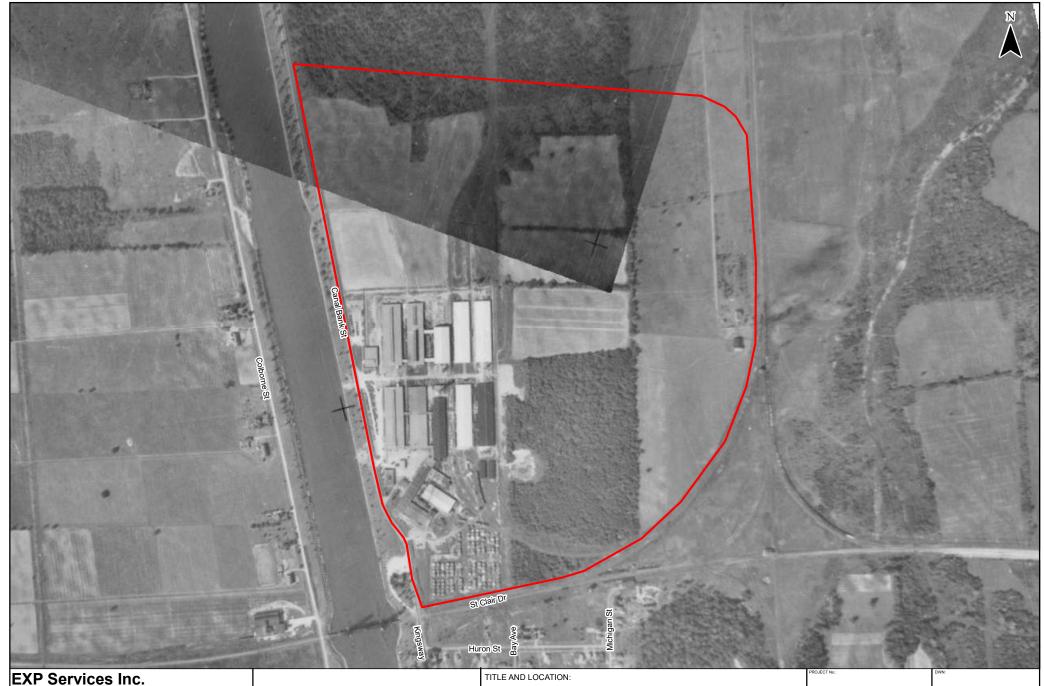
OJECT No.:	DWN:
HAM-00801631-A0	AC
ALE:	CHKD:
AS NOTED	SH
MARCH 2019	FIG. Na: H2

1965	 Further industrial expansion has occurred on the western portion of the Site with the addition of several rectangular shaped buildings (north of the existing industrial buildings). A road system has been established which transects the Site in half from east to west. Vacant agricultural land remains on the east portion of the Site. The surrounding areas appear similar to that observed in the 1954 aerial photograph.
1976	 The Site appears similar to that observed in the 1965 aerial photograph, however, what appears to be a dirt road is seen on the eastern boundary. The Old Welland Canal has been terminated northwest of the Site. Evidence of soil disturbance is seen north adjacent to the Site and can be attributed to the development of the highway and rail line observed at the time of the Site visit. Further residential development is seen to the south of the Site. The Welland Canal is seen east of the Site.

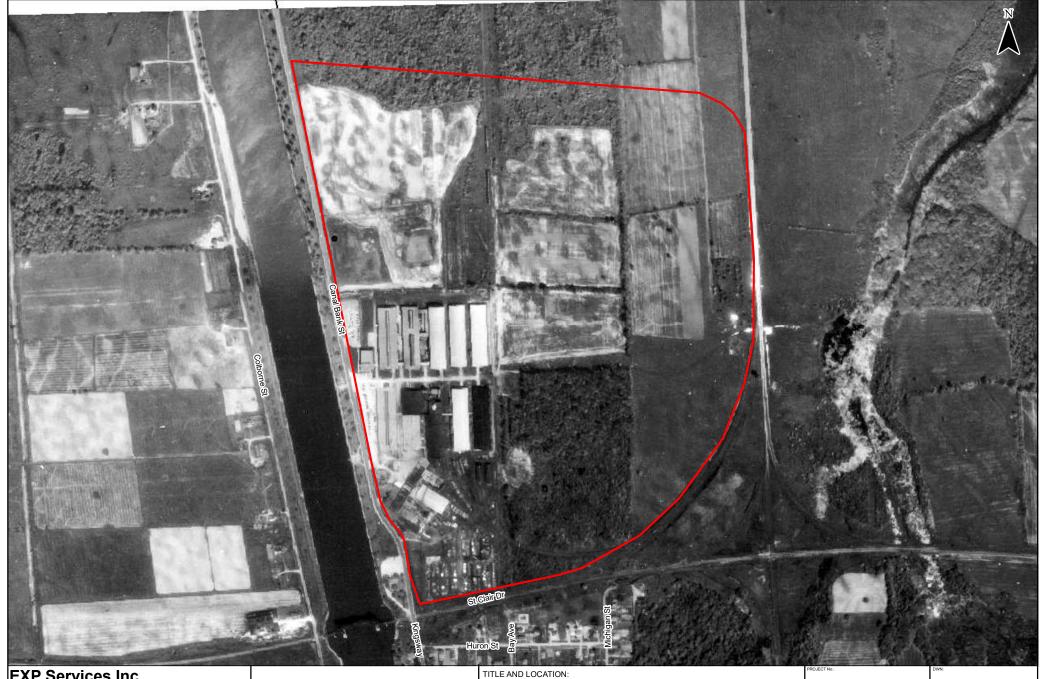
PROJECT No.:	DWN:
HAM-00801631-A0	AC
SCALE:	CHKD:
AS NOTED	SH
MATE:	FIG. No.:
MARCH 2019	H3

1988	 Areas of disturbed soil or piles of debris area seen on the east portion of the Site. The remaining areas of the Site appear similar to that observed in the 1976 aerial photograph. The highway and rail system have been developed north of the Site.
2000	 A circular track is seen on the southwest portion of the Site. The remaining areas of the Site appear similar to that observed in the 1988 aerial photograph. Two structures have been developed north of the Old Welland Canal and docks can been seen in the water.
