555 Canal Bank Street, Welland Ontario

Phase Two Environmental Site Assessment

HAM-00801631-A0

2019-08-20

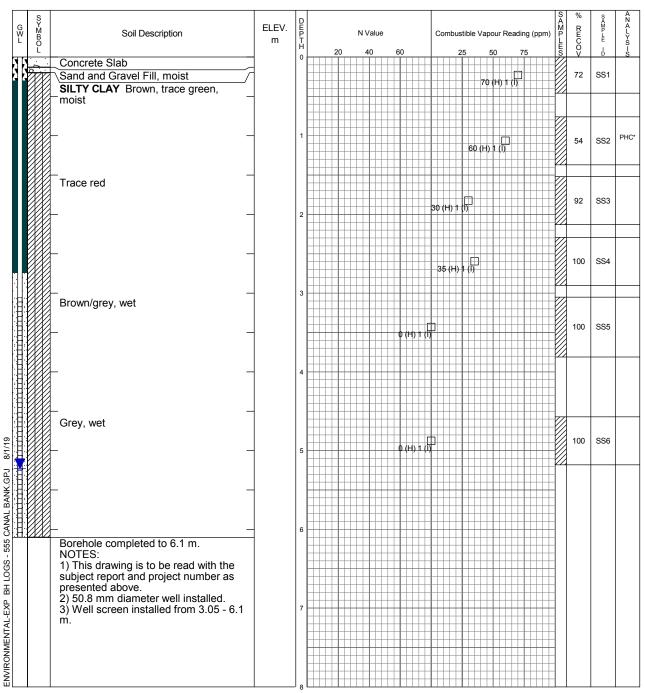
Log of Borehole BH/MW102

Project No.	HAM-00801631-A0				Drawing No.		2	
Project:	Phase Two ESA				Sheet No.	_1	_ of	_1
_ocation:	555 Canal Bank Street, Welland,	ON						
	Refer to borehole location plan	_						
Date Drilled:	June 25, 2019	Chemica BTEX	al Analysis Benzene, Toluene, Ethylbenzene and	Xylenes	* Duplic	ate Sa	ample	
Orill Type:	CME Truck Mounted	ING	Metals and Inorganics	PCB	Polychlorinat		,	
Datum:	Geodetic	- MET - PAH - PEST	Metals Polycyclic Aromatic Hydrocarbons Organochlorine Pesticides	VOC	Petroleum Hy Volatile Orga			` ′

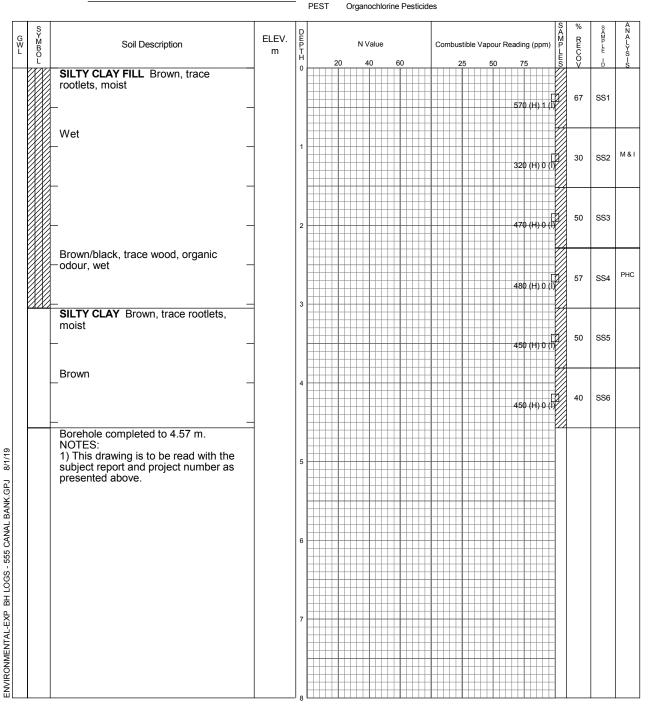
Log of Borehole BH103

Project No.	<u>HAM-00801631-A</u> 0				Drawing No.		3	
Project:	Phase Two ESA				Sheet No.	_1	of	_1_
_ocation:	555 Canal Bank Street, Welland,	ON						
	Refer to borehole location plan	_						
Date Drilled:	July 2, 2019	Chemic BTEX	al Analysis Benzene, Toluene, Ethylbenzene and	Xylenes	* Duplic	ate Sa	ımple	
Orill Type:	9580- VTR Power probe	ING	Metals and Inorganics	PCB	Polychlorinate	ed Bipl	nenyls	
71	·	- MET	Metals	PHC	Petroleum Hy	drocar	bons (F1-F4)
Datum:	Geodetic	PAH	Polycyclic Aromatic Hydrocarbons	VOC	Volatile Organ	nic Co	mpoun	ds

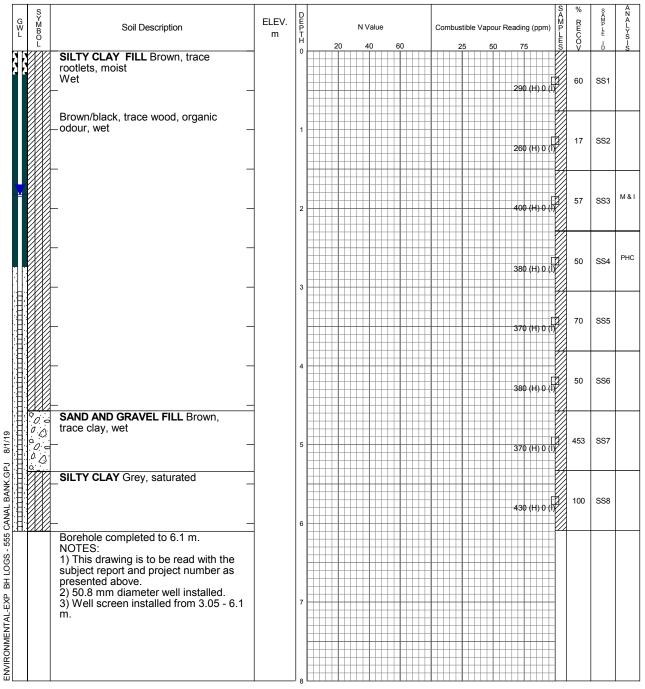
O							
Project No.	<u>HAM-00801631-A</u> 0				Drawing No.		4	
Project:	Phase Two ESA				Sheet No.	_1_	of _	1
_ocation:	555 Canal Bank Street, Welland	, ON						
	Refer to borehole location plan							
Date Drilled:	July 2, 2019	Chemic BTEX	cal Analysis Benzene, Toluene, Ethylbenzene ar	nd Xylenes	* Duplic	ate San	nple	
Orill Type:	9580- VTR Power probe	ING — MET	Metals and Inorganics Metals	PCB PHC	Polychlorinate Petroleum Hy		•	=1 E4)
Datum:	Geodetic	PAH PEST	Polycyclic Aromatic Hydrocarbons Organochlorine Pesticides	VOC	Volatile Organ		,	,
S Y	ELE'	V. E			SAM	% R	S A M	A N A

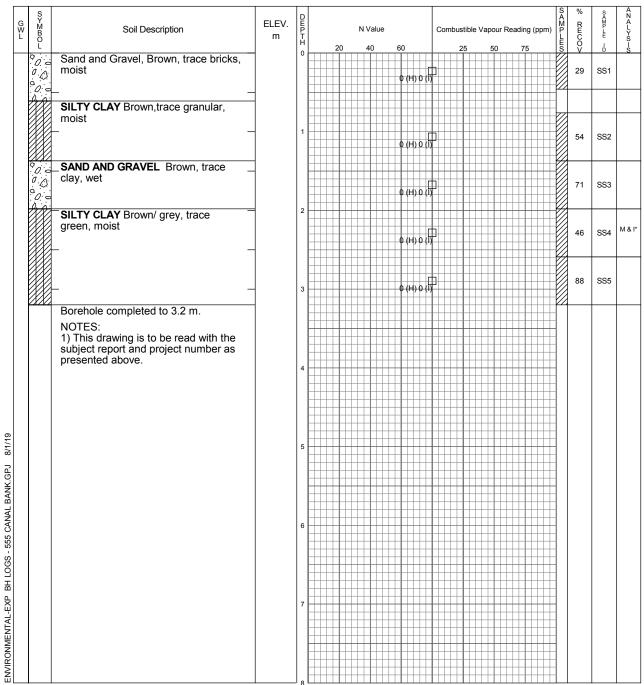
Project No.	HAM-00801631-A0			ľ	Drawing No.		5		
Project:	Phase Two ESA				Sheet No.	_1	of	1	
_ocation:	555 Canal Bank Street, Welland,	ON							
	Refer to borehole location plan	_							
Date Drilled:	June 25, 2019	Chemic BTEX	al Analysis Benzene, Toluene, Ethylbenzene and	d Xylenes	* Duplic	Duplicate Sample			
Orill Type:	CME Truck Mounted	ING — MET	Metals and Inorganics Metals	PCB PHC	Polychlorinate		,	F1-F4)	
Datum:	Geodetic	PAH PEST	Polycyclic Aromatic Hydrocarbons Organochlorine Pesticides	VOC	,	•	,	,	
s		Д			S	%	S A	A N

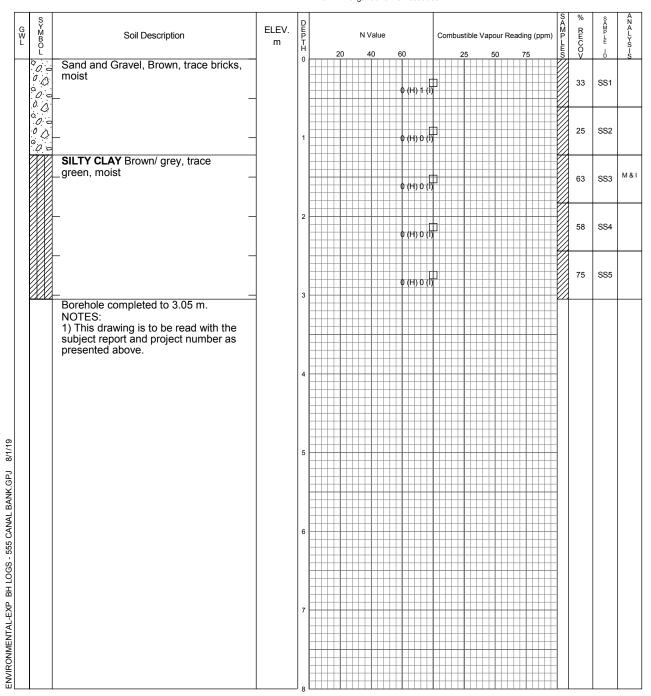
Project No.	<u>HAM-00801631-A</u> 0				Drawing No.		6	
Project:	Phase Two ESA				Sheet No.	_1	of	_1
_ocation:	555 Canal Bank Street, Welland,	ON						
	Refer to borehole location plan	_						
Date Drilled:	June 25, 2019	Chemic BTEX	al Analysis Benzene, Toluene, Ethylbenzene and	Xylenes	* Dupli	cate Sa	ample	
Orill Type:	CME Truck Mounted	ING	Metals and Inorganics	РСВ	PCB Polychlorinated Bipl		,	
Datum:	Geodetic	— MET — PAH — PEST	Metals Polycyclic Aromatic Hydrocarbons Organochlorine Pesticides	PHC	Petroleum H Volatile Orga	,	,	` ′

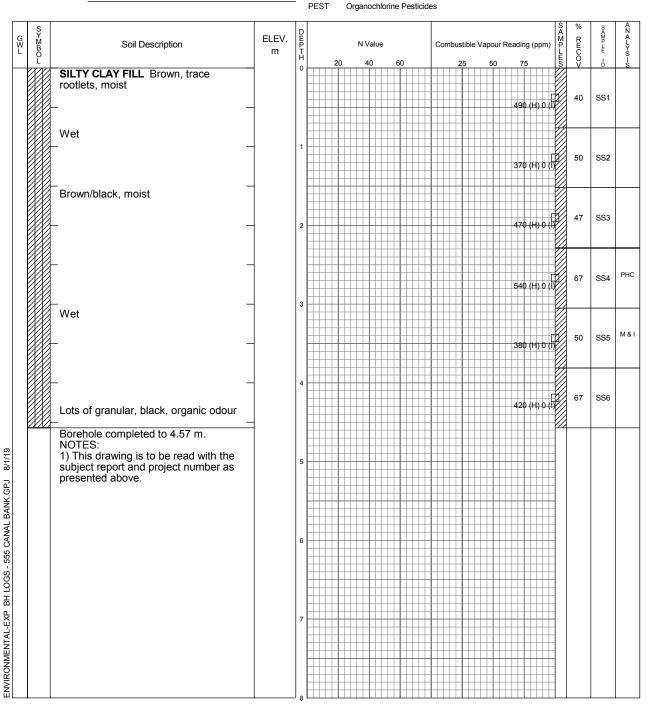
Project No.	<u>HAM-00801631-A</u> 0				Drawing No.		7	
Project:	Phase Two ESA				Sheet No.	_1	of	1
_ocation:	555 Canal Bank Street, Welland,	ON						
	Refer to borehole location plan	_						
Date Drilled:	July 2, 2019	Chemic BTEX	al Analysis Benzene, Toluene, Ethylbenzene and	Xylenes	* Duplic	ate Sa	ample	
Orill Type:	9580- VTR Power probe	ING	Metals and Inorganics	PCB	Polychlorinate	ed Bipl	nenyls	
, , ,	<u> </u>	- MET	Metals	PHC	Petroleum Hy	drocar	rbons (F1-F4)
Datum:	Geodetic	PAH	Polycyclic Aromatic Hydrocarbons	VOC	Volatile Organ	nic Co	mpoun	ds

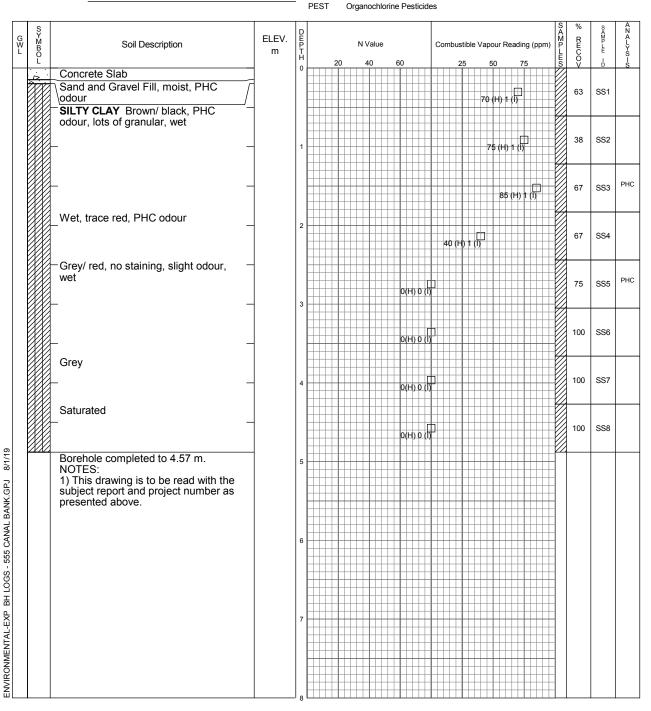
Project No.	<u>HAM-00801631-A</u> 0			I	Drawing No.		8	
Project:	Phase Two ESA				Sheet No.	_1	of	1
_ocation:	555 Canal Bank Street, Welland,	ON						
	Refer to borehole location plan	_						
Date Drilled:	June 25, 2019	Chemic BTEX	al Analysis Benzene, Toluene, Ethylbenzene and	Xylenes	* Duplic	ate Sa	mple	
Orill Type:	CME Truck Mounted	ING	Metals and Inorganics	PCB	Polychlorinate		,	
Datum:	Geodetic	MET PAH	Metals Polycyclic Aromatic Hydrocarbons	PHC VOC	Petroleum Hy Volatile Organ		,

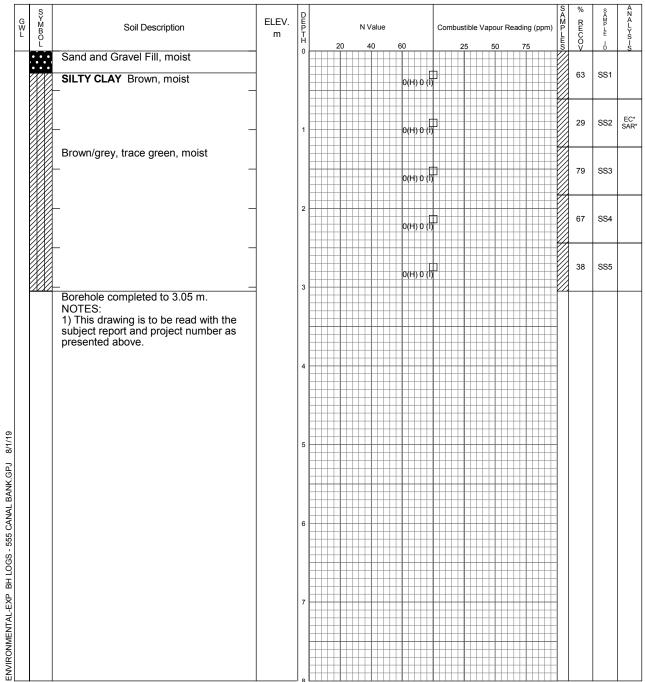
,							
Project No.	<u>HAM-00801631-A</u> 0					Drawing No		9	
Project:	Phase Two ESA					Sheet No.	_1	_ of	1_
Location:	555 Canal Bank Street, Wel	land, (NC						
	Refer to borehole location pl	an	_						
Date Drilled:	June 25, 2019		Chemic BTEX	al Analysis Benzene, Toluene, Eth	ylbenzene and Xyler	nes * Dup	licate Sa	ample	
Drill Type:	CME Truck Mounted		ING - MET	Metals and Inorganics Metals	P	CB Polychlorin		,	E1 E1)
Datum:	Geodetic		PAH	Polycyclic Aromatic Hy	drocarbons V	OC Volatile Org	•		
	_		PEST	Organochlorine Pestici	des				
S Y M	Soil Description	ELEV.	DEP	N Value	Combustible Vano	ur Reading (ppm)	% B	S A M P	A A L

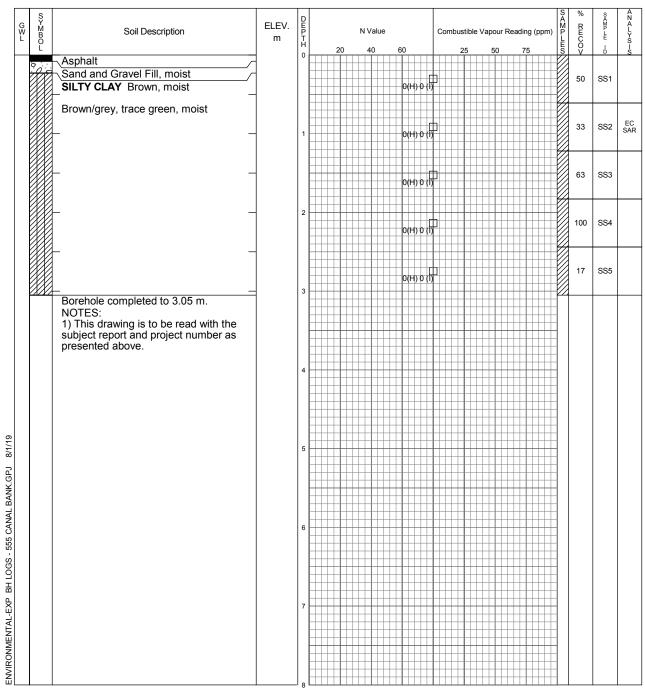
Project No.	HAM-00801631-A0			Draw	ing No.		10	
Project:	Phase Two ESA			Sh	eet No.	_1	of	1
_ocation:	555 Canal Bank Street, Welland, C	N						
	Refer to borehole location plan							
Date Drilled:	June 25, 2019	Chemic BTEX	al Analysis Benzene, Toluene, Ethylbenzene and Xyle	enes *	Duplica	ate Sa	mple	
Orill Type:	CME Truck Mounted	ING	· · · · · · · · · · · · · · · · · · ·		olychlorinate	•	,	
,,	Geodetic	MET PAH			etroleum Hyo olatile Organ		,	,
Oatum:	Geodelic	PEST	Organochlorine Pesticides	VI VI	Jiaule Organ	iic COI	iipouri	us

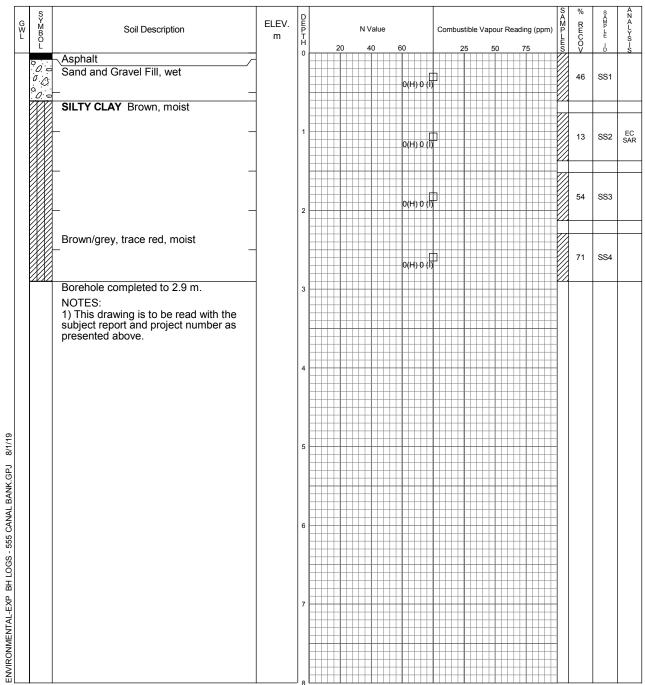
Project No.	HAM-00801631-A0				Drawing No.		12	
Project:	Phase Two ESA				Sheet No.	_1	of	_1_
Location:	555 Canal Bank Street, Welland, C	N						
	Refer to borehole location plan							
Date Drilled:	June 26, 2019	Chemic: BTEX	al Analysis Benzene, Toluene, Ethylbenzene and	Xylenes	* Duplic	ate Sa	mple	
Drill Type:	CME Truck Mounted	ING MET	Metals and Inorganics Metals	PCB PHC	Polychlorinate Petroleum Hy		,	F1_F4)
Datum:	Geodetic	PAH PEST	Polycyclic Aromatic Hydrocarbons Organochlorine Pesticides	VOC	,		,	,

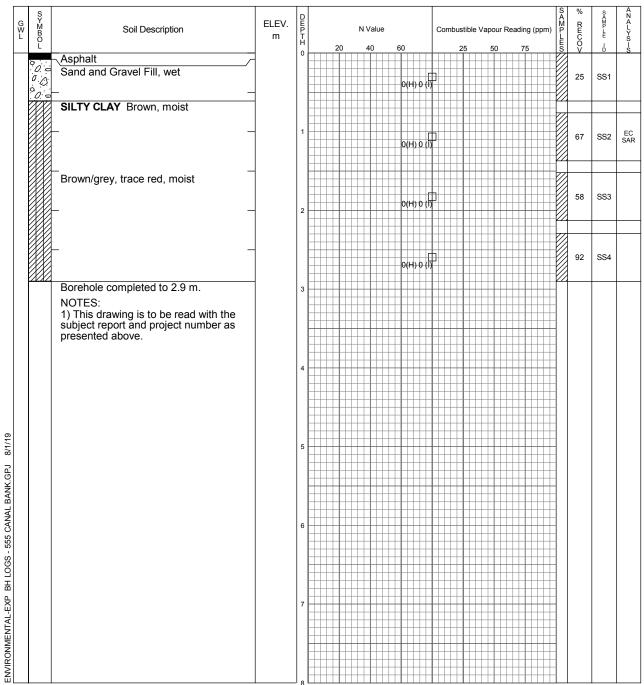
Project No.	<u>HAM-00801631-A</u> 0				Drawing No.		13	
Project:	Phase Two ESA				Sheet No.	_1	of	_1_
Location:	555 Canal Bank Street, Welland,	ON						
	Refer to borehole location plan	_						
Date Drilled:	June 26, 2019	Chemic BTEX	al Analysis Benzene, Toluene, Ethylbenzene and	l Xylenes	* Duplic	cate Sa	ample	
Drill Type:	CME Truck Mounted	ING	Metals and Inorganics	PCB	Polychlorinat		,	
Datum:	Geodetic	MET PAH PEST	Metals Polycyclic Aromatic Hydrocarbons Organochlorine Pesticides	VOC	Petroleum Hy Volatile Orga	•		,
S S	FLEV	D			S A M	% R	S A M	A N A

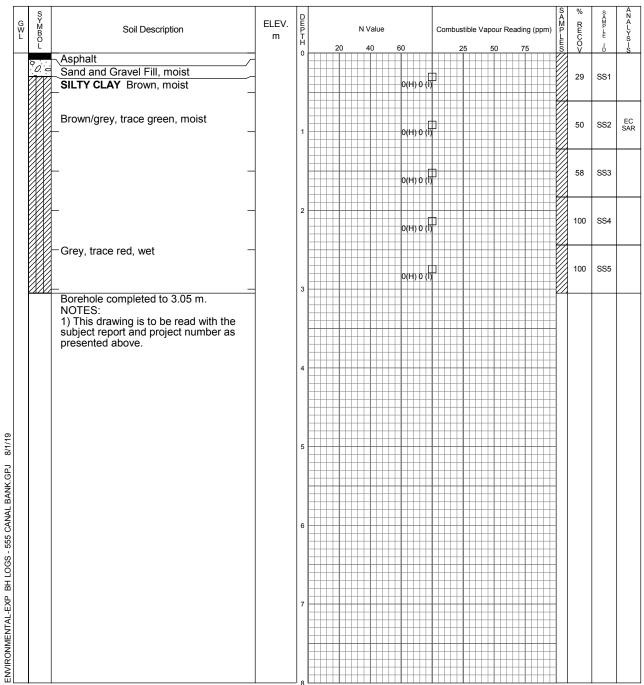
Project No.	HAM-00801631-A0					Drawing No.		17	
Project:	Phase Two ESA					Sheet No.	_1	of	1_
Location:	555 Canal Bank Street, Well	and, (NC						
	Refer to borehole location plant	an	_						
Date Drilled:	June 25, 2019		Chemic BTEX	al Analysis Benzene, Toluene, Eth	nes * Dupli	cate Sa			
Drill Type:	CME Truck Mounted		ING - MET	Metals and Inorganics Metals		,	ted Biphenyls		
Datum:	Geodetic		PAH PEST	Polycyclic Aromatic Hy Organochlorine Pestici	rdrocarbons V	OC Volatile Orga	•	,	,
			FEST	Organochionne Pestici	ues	TeT	0/		Δ
G S Y	Sail Departation	ELEV.	D	N Value	Combustible Vans	S A M	% <u>B</u>	S A M P	Ñ A L
