Hydrogeological Investigation

555 Canal Bank Street, Welland, ON

Project Number: HAM-00801631-A0

Prepared By: EXP Services Inc. 1595 Clark Boulevard Brampton, ON L6T 4V1

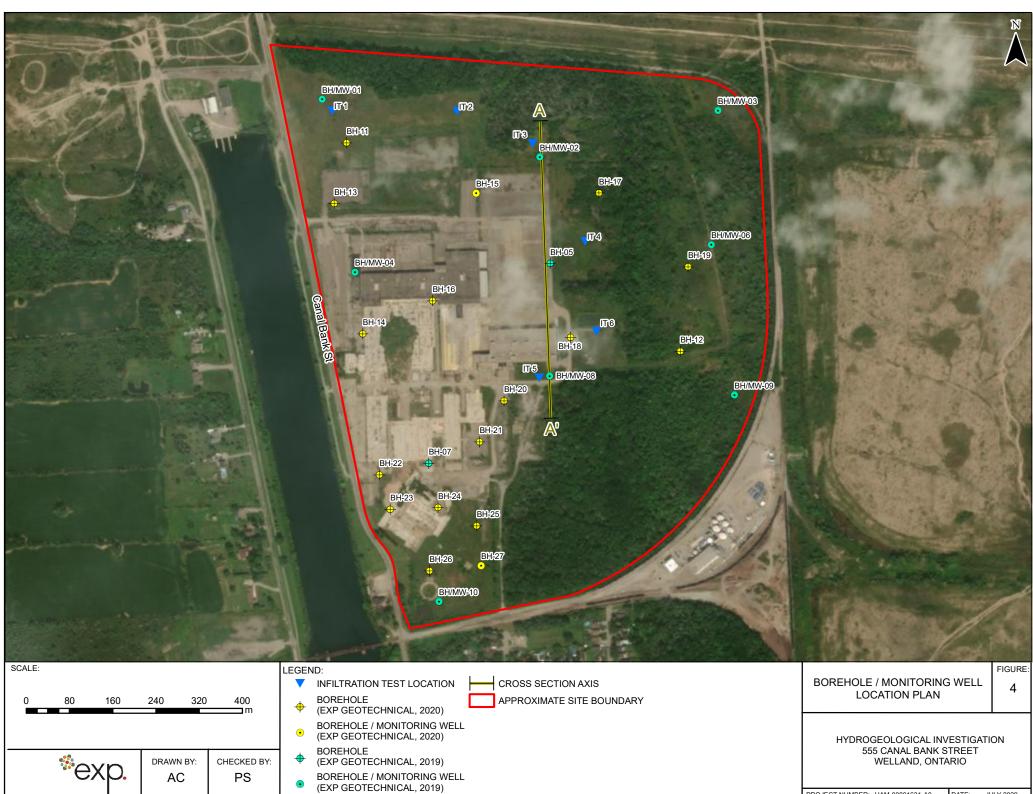
A total of six (6) infiltration tests were completed at the selected locations, including IT-1 through IT- 6 on July 8 and 27, 2020. The hydraulic conductivities of unsaturated soil horizons were estimated using the Reynold's method (Reynolds et.al, 2015 and Reynolds, 2016) as per the Toronto and Region Conservation Authority's guidelines (TRCA, 2012 and TRCA 2019). A summary of the hydraulic conductivity (K) values estimated from the infiltration tests are provided in Table 3-3. The calculations are provided in Appendix C. The infiltration test locations are shown on Figure 4.
